SERVICE BULLETIN

from: TRIO-KENWOOD COMMUNICATIONS, INC.

SUBJECT: TS-120S ANT INPUT TRNASTORMER REPLACEMENT

DATE 7/12/79

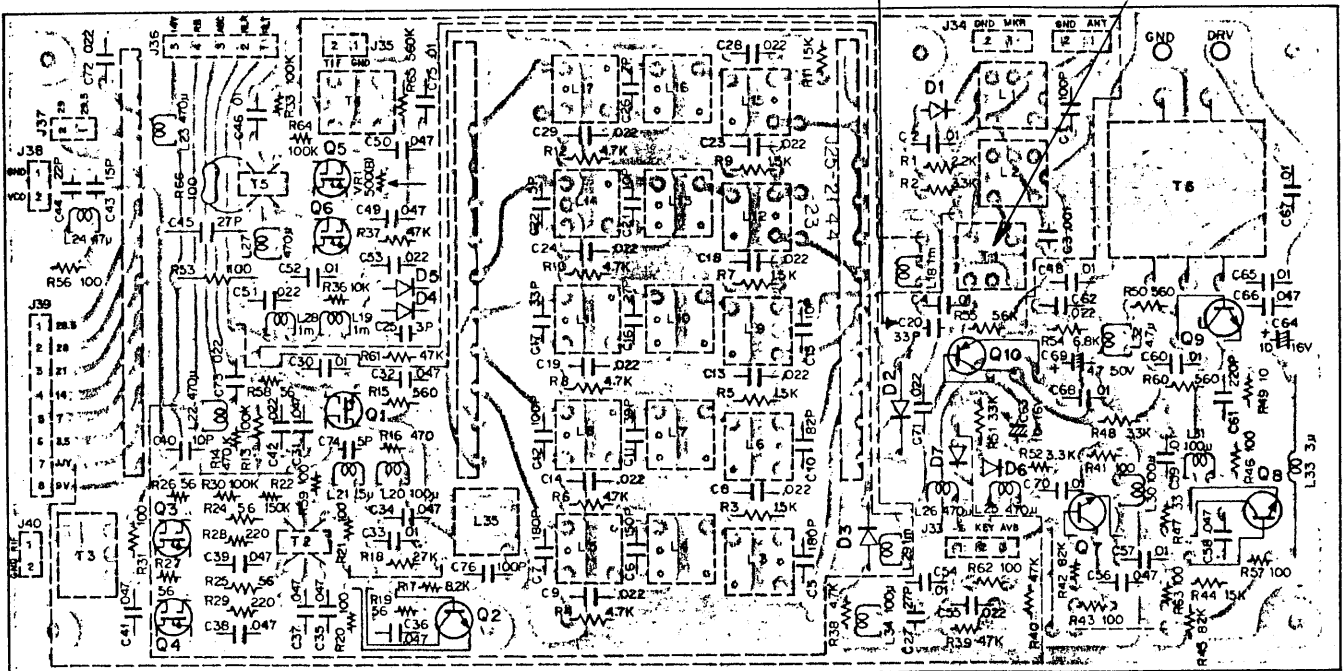
▼ RF UNIT (X44-1260-01)

TS-120S transceivers subject to strong static fields or similar hi current atmospheric discharges may suddenly exhibit low RX sensitivity on all bands. TX will be OK. You may suspect T1 on the RF unit, X44-1260-01.

First production transceivers will have a 15pF cap for C20. When changing T1, also replace C20 with a 33pF capacitor, and repeak the circuit.

When replacing or ordering T1, L43-0696-35, also check the value of C20. If it is 33pF, just replace and repaek the transformer.

Old part number;	L34-0696-05	ANT coil
New Part number;	L34-0696-35	ANT coil
Old capacitor was 15pf,	replace with	
New Part number	CC45RH1H330J	33pf
