SERVICE BULLETIN

from: TRIO-KENWOOD COMMUNICATIONS, INC.

43

SUBJECT: TS-520S -6V DC SUPPLY FAILURE

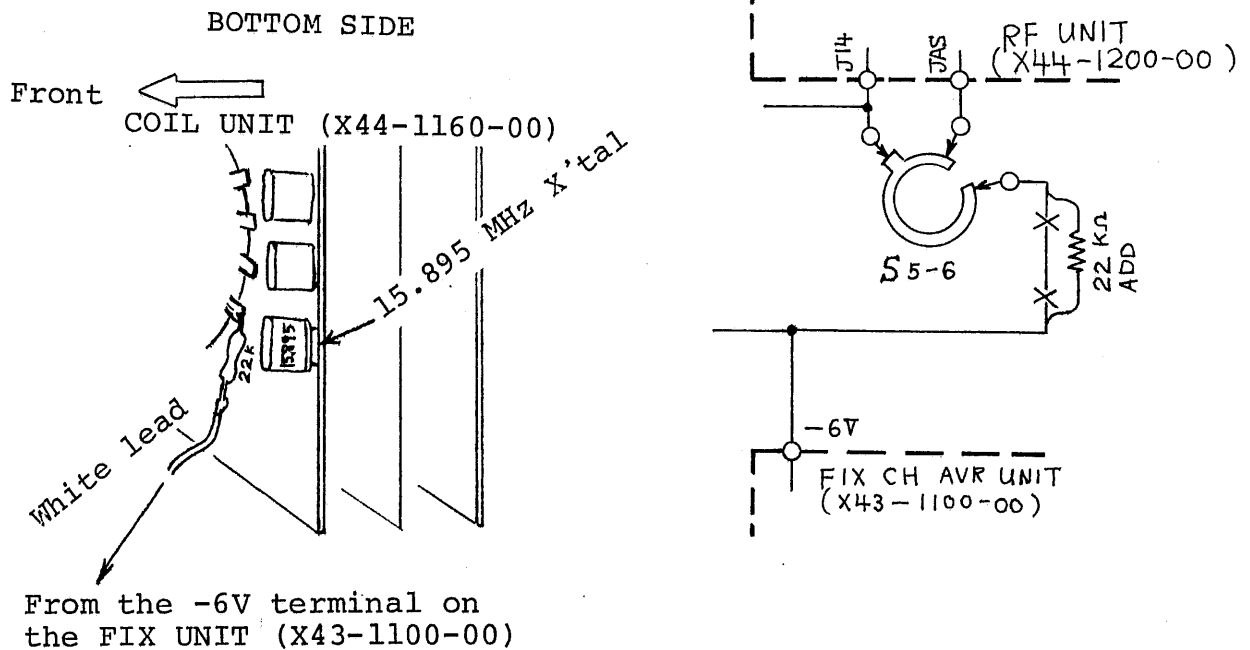
When troubleshooting a TS-520S, check all power supply voltages, including the -6V DC supply. Symptoms such as dead, blown 2A DC fuse and now dead, low RX, no TX, or similar may occur after switching between 80 & 40M.

Cause of failure may be traced to an intermittent shorting between the 14V DC & -6 DC supplies as the Band Switch is rotated between 40 & 80 M. This will weaken or destroy D8, 6V Zener on the FIX CH AVR unit. To prevent repeat failure, break the WHITE lead & install a 22K ohm $\frac{1}{2}$ W resistor at the Bandswitch S5-6, between the -6V supply line and switch terminal. And of course replace D8 on the FIX CH AVR unit, X43-1100-00.

New Part 22k ohm $\frac{1}{2}$ W
