SERVICE BULLETIN

56

TS-180S DFC

DATE 9/10/79

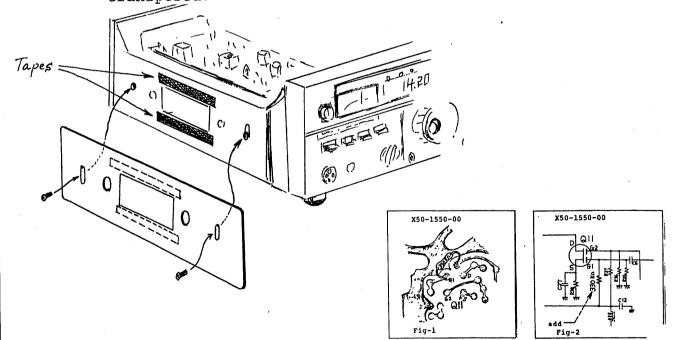
For complaints of either induced power supply hum, or intermittent frequency stability while using the DFC, perform the following changes to the VCO unit X50-1550-00:

- *1. Install a 330K ohm resistor between Q11 G1 & the 8V line. Connect from L7 at C12 to Q11 G1, at R35.
- *2. Replace L12 68uH with new part L40-6831-21.
- *3. Replace L13 150uH with new part L40-1541-27.
- *4. Install magnetic shield as illustrated. Use the two existing screws, plus double faced tape to prevent vibration.
- * New Part
