SERVICE BULLETIN

from: TRIO-KENWOOD COMMUNICATIONS, INC.

TR-2400

SUBJECT: TR-2400 OFFSET FAILURE

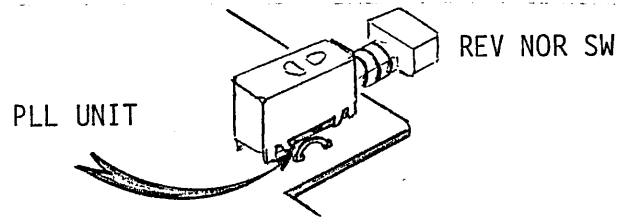
For intermittent or no offset, suspect an intermittent short between the metal body of the REV NOR SW and an adjacent jumper on the PCB, or intermittent contact between the volume control metal body and the PLL PCB.

1. Disassemble the radio and inspect the board to the right of the REV/NOR SW. Using a small flat blade screwdriver or similar tool, gently pry the short metal jumper and the metal body switch tab apart. This should clear the offset trouble. (Fig.1)
