# SERVICE BULLETIN

TR-7800

# 829

SUBJECT: TR-7800 LOSS OF MEMORY

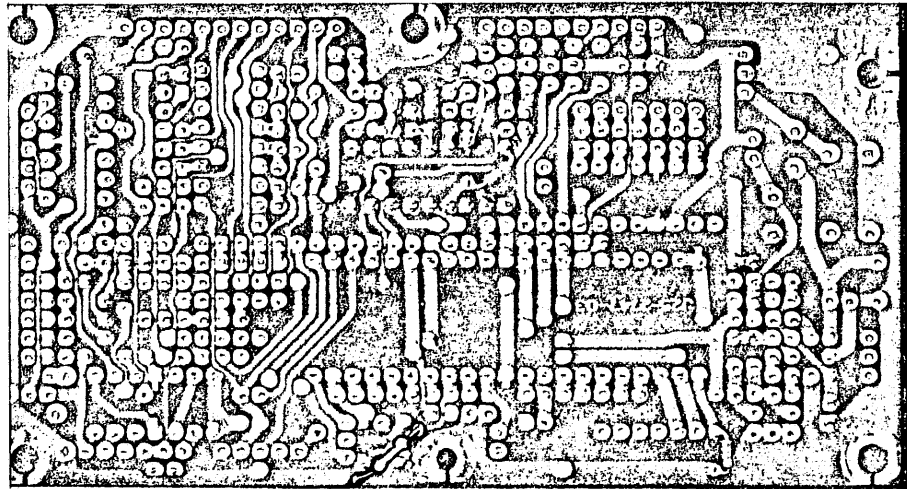
Intermittent loss of memory may be corrected by adding one resistor at the  $\mu$ -processor on the Control unit.

470 K $\Omega$

1. Remove bottom cover, 4 screws.
2. From the Control unit X53-1180-xx unplug the rear mounted connectors 8-11.
3. Remove 6 screws from the board.
4. Swing the unit forward.
5. As illustrated, install a  $470K\Omega$  1/8W or larger resistor from connector 11, "UP" pin, to ground. ( $\mu$ -proc pin 35, PA2 port). Space is limited: Be certain not to create a solder bridge when installing the resistor.
6. Reverse steps 4-1 for reassembly.
