SERVICE BULLETIN

from: TRIO-KENWOOD COMMUNICATIONS, INC.

TS-120S

SUBJECT: TS-120S ANT INPUT TRANSFORMER REPLACEMENT

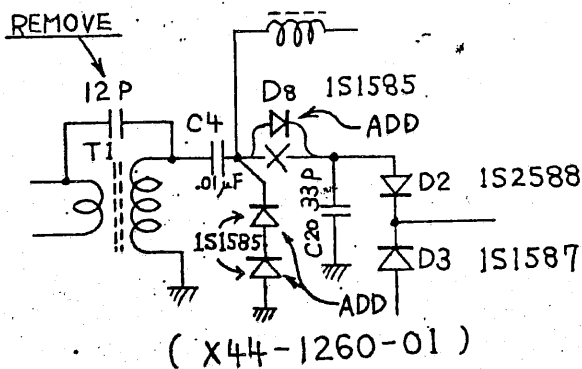
Transceivers subject to strong static fields, high RF, or similar high current atmospheric discharges may suddenly exhibit low sensitivity on all bands. TX will not be affected. Suspect T1 on the RF unit, X44-1260-01.

When replacing T1, L43,0696-35, check that the value of C20 is 33pf. Early units may have a 15pf for C20, and may have T1 as L43-0696-05. In either case, replace the transformer with an L34-0929-15. If C20 is 15pf, replace it with a 33pf capacitor. Since T1 is a broadband transformer, no adjustment is necessary.

In addition, add two 1S1587 diodes after the transformer as shown to further protect the receiver.
