SERVICE BULLETIN

TS-120S

#832R

SUBJECT: TS-120S FULL CW OUTPUT IN SSB MODE

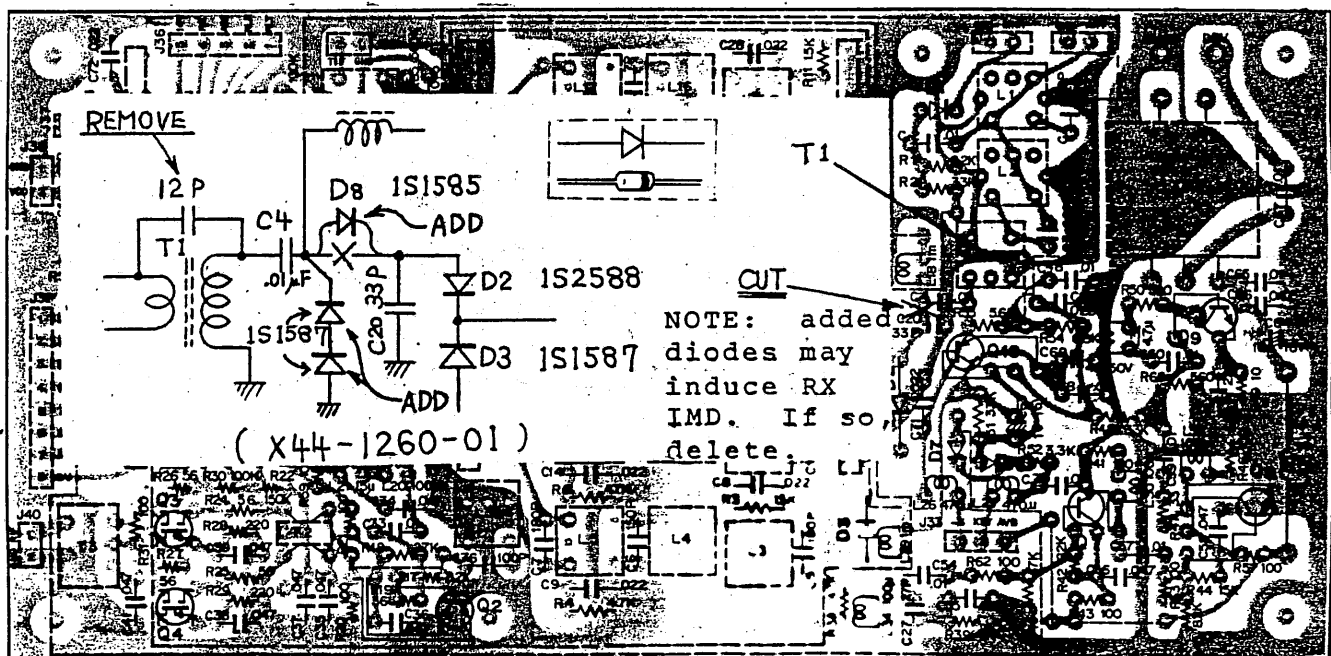
Leakage or shorting of D2, D3, or D8 on the RF unit X44-1260-01 will provide an unwanted DC voltage path which gives full CW output while in the SSB mode. The Carrier control has no effect, and RX is not affected.

Replace D2 1S2588, D3 1S1587, and D8 1S1585. Install two 1S1587 diodes between C4 and D8, as shown.

Radios before serial 080001 may not have D8. This may be added to the foil side of the board.

To install, swing the IF unit up. Remove the shield from under the IF unit to expose the foil side of the RF unit. Use a razor or X-ACTO knife to carefully cut the land between C4 and C20. Solder D8 across the cut, observing diode polarity. Some units have a 12pf cap soldered on the foil side of this board across T1, and C20 will be missing. Remove the 12pf and install a 33pf in C20's position. Solder the 1S1587's from the junction of C4 and D8 to ground.
