SERVICE BULLETIN

from: TRIO-KENWOOD COMMUNICATIONS, INC.

TS-120S

SUBJECT: TS-120S TX OSCILLATION (SUPERCEDES 821

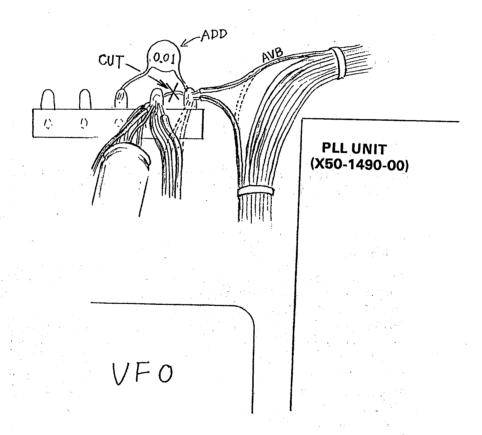
The TS-120S may exhibit intermittent oscillation on the 15M, 10M, and/or 20M bands. Symptoms may be no control of Carrier level, full current or ALC in either CW or SSB after initial keying or modulation, or "full output both forward and reflected".

7. As illustrated, carefully cut the cable ties on the wire harness (without cutting the wires) as it rounds the corner behind the PLL unit X50-1490-00.

8. Seperate the AVB line, a white/brown line from the filter unit X51-1200-00 to the RF unit X44-1260-01.

9. Adjacent to the rear of the PLL and to the left you will see a five pin terminal strip. The two right-hand most terminals are bridged. WITHOUT BREAKING THE TERMINAL OR STRIP, remove the heavy yellow, and light red and green lines and transfer them to the adjacent terminal. There will now be seven lines, plus the positive end of Cl on the second terminal. Be sure to cut the wire jumper between these two terminals.

- 10. The free terminal will be a tie point for the AVB line bypass capacitor. Solder a .01µF 50V disc ceramic (C52-1710-36) between ground and the first free terminal. Use spaghetti to insulate the leads. Then solder the AVB line to the .01µF cap.
- 11. Retie the cable harness with nylon cable ties (J61-0401-05).
- 12. Replace the covers and speaker lead. Power-up and verify correct operation.
