SERVICE BULLETIN

from: TRIO-KENWOOD COMMUNICATIONS, INC.

TR-9000

SUBJECT: TR-9000 Transmitter Sideband Carrier Balance

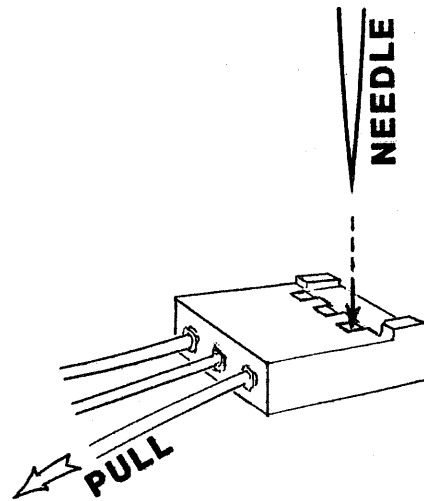
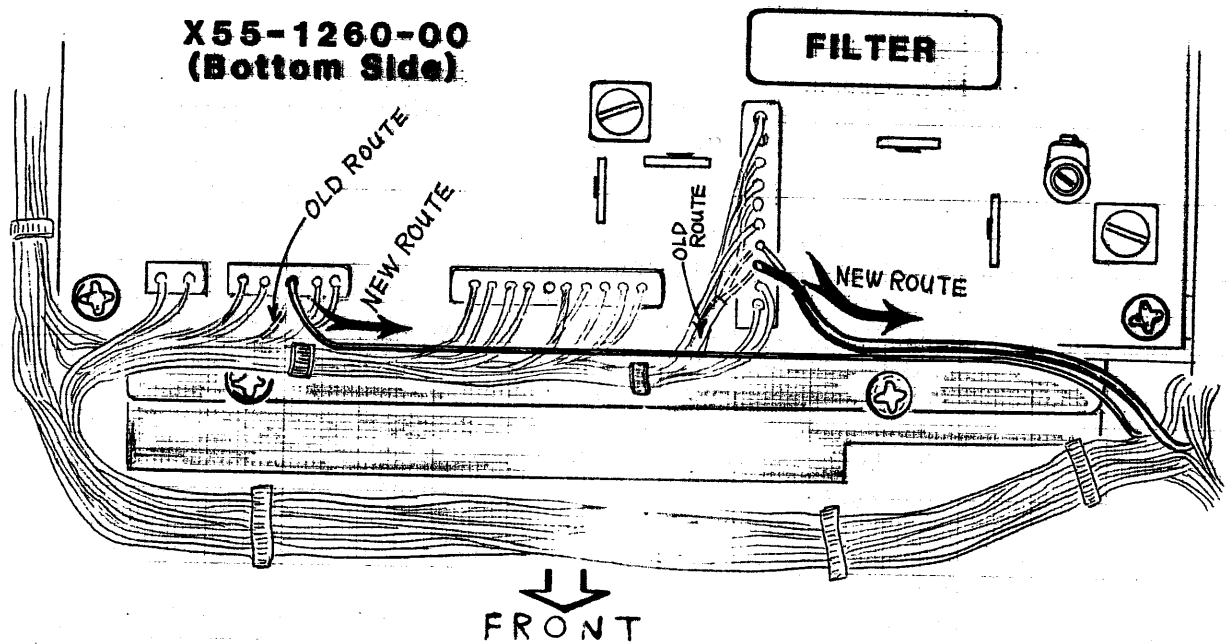
Distorted sideband transmission may have one of two causes. If normal alignment does not cure the problem, distortion or poor carrier suppression may be improved by rerouting two leads in the wire harness.

1. Remove the bottom cover and unplug the speaker.
2. With the radio upside down and facing forward, locate connectors 8 and 10 at the front of the RX unit X55-1260-00. Connector # 8, pin 3 (violet) is the -6V DC line from the TX unit, connector # 31, pin 1. Connector # 10, pins 7 (signal) and 8 (ground) (green coaxial cable) is the MS pins 5 (sig) and 4 (gnd).

4. Carefully unplug each of these connectors by gripping the connector housing with a long-nosed plier.
5. Extract the terminal from the housing by depressing the locking tab and simultaneously withdrawing the lead with terminal. (see illustration on page 2).

6. Reroute these two lines from the behind the Mode switch, between the chassis and control unit, then left to their original connectors. Reinstall the terminals in their original positions in the connector housing.
