SERVICE BULLETIN

TS-660

#856

SUBJECT: TS-660 Microprocessor Latchup

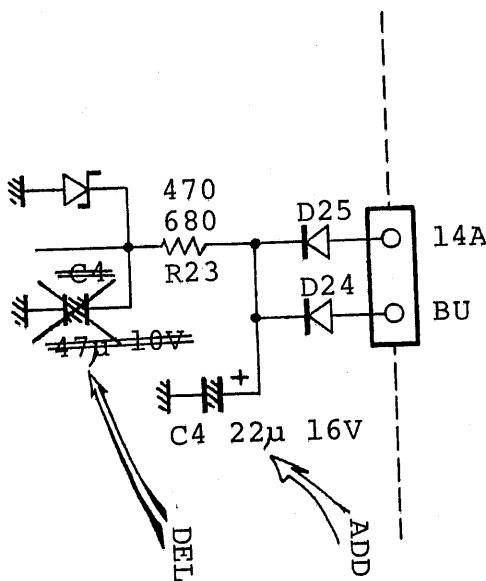
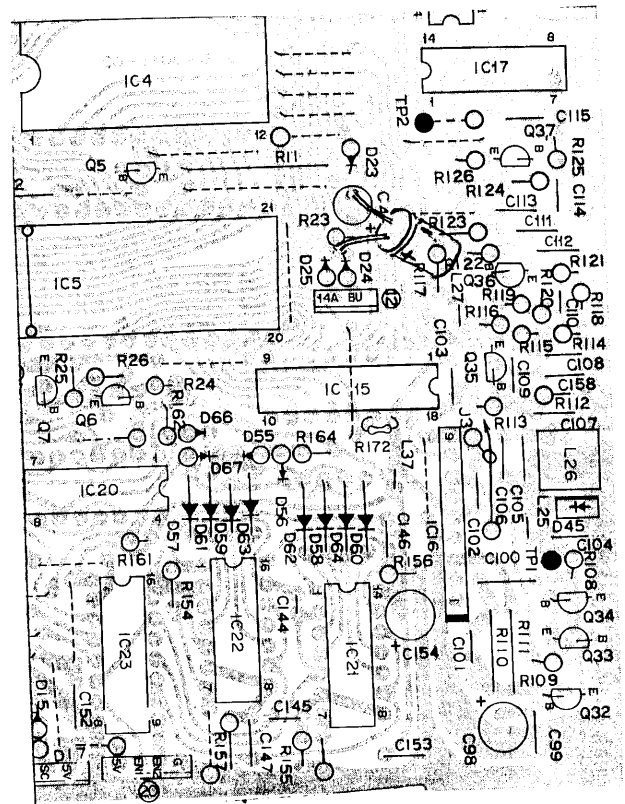
On the Control unit X53-1220-00:

Microprocessor latchup may occur if the power switch is cycled several times in quick succession, if the supply is turned off while the power switch remains on, or if the power supply is turned on with the transceiver already on. Symptom will be no display, erroneous display, or locked display. Change two components on the Control unit to prevent further trouble.

1. Replace R23 680 Ω with a 470 Ω resistor (RD14CB2E471J).
2. Remove and delete C4 47 μ F
3. Add a 22 μ F 16V electrolytic (CE04W1C220M) on the foil side of the board between D24, R23 (positive) and ground (negative).
