## SERVICE BULLETIN

from: TRIO-KENWOOD COMMUNICATIONS, INC.

TR-2500

SUBJECT: TR-2500 RX IMD Improvement

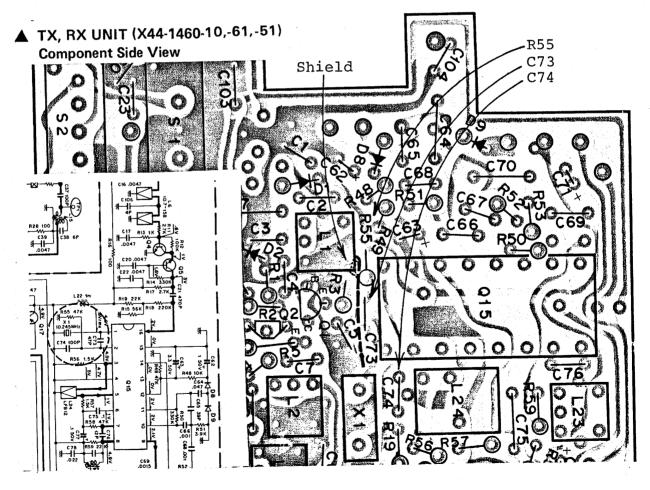
RX intermodulation distortion may be improved by reducing second conversion oscillator harmonic content and level. No adjustments are required. This may be applied to a unit specifically exhibiting out-of-band intermodulation distortion. It is, however, not a general improvement.

R55 from 47kΩ delete
C73 47pf to 33pf (CC45SL1H330J)
C74 100pf 150pf (CC45SL1H151J)

Add a shield between Q1, (R3,C5) and C73 (from L1 to near X1).
