SERVICE BULLETIN

TR-9000

#859

SUBJECT: TR-9000 Temperature Stability Improvement

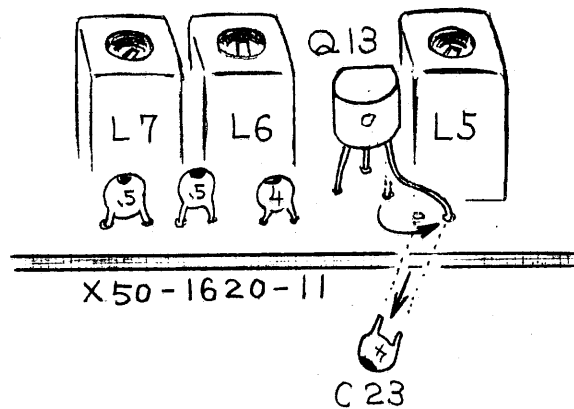
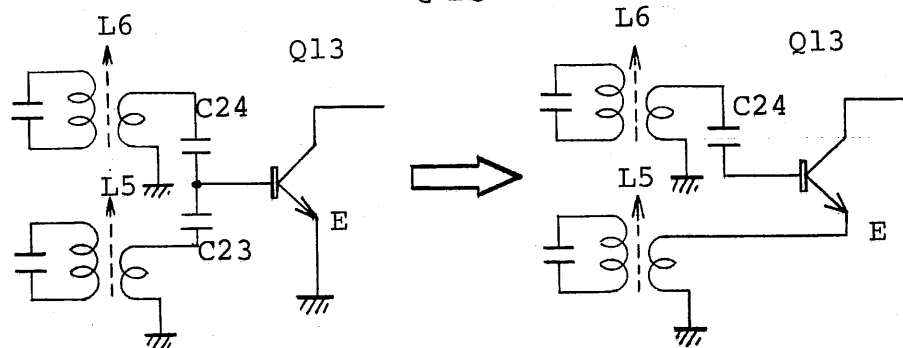
TP-3

PLL noise or unlock at high temperature may be cured by changing a mixer feed point in the PLL.

Measure TP3 on the PLL unit. If greater than 0.5V RMS signal is available, this change will not be required. If less than this level is present, proceed.

On the PLL unit X50-1620-00 at Q13:

1. Remove and delete C23.
2. Connect Q13 emitter to L5 "hot" (original C23 take-off.)
3. Realign L5, 6, 7 for at least 0.5V RMS at TP3.

Alignment Note: To align L6 & 7, first position the slugs flush with the tops of the coils, then alternately adjust these two coils for maximum output at the first peak into the coil (fundamental frequency). Then align L5 for maximum.
