SERVICE BULLETIN

TR-7800, TR-7850

#860

SUBJECT: Memory Channel 7 Indicator Erratic

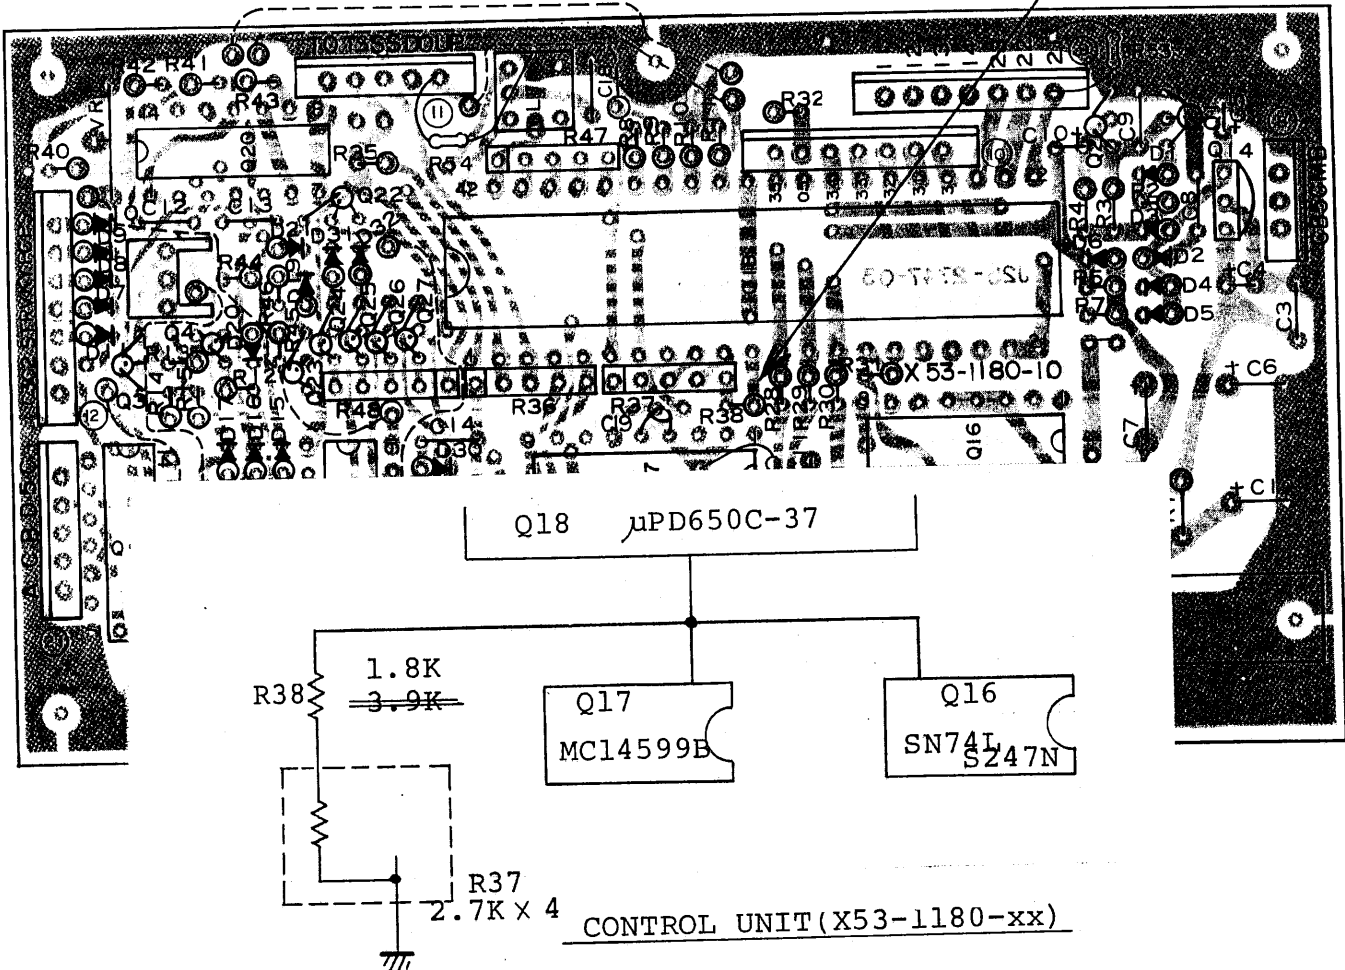
▼ CONTROL UNIT (X53-1180-XX) XX: 10(K), 61(W)(T)

When Memory Channel 7 is selected, the LED may fail to indicate the number 7, although frequency is correctly recalled and all other operations are normal. Cause is incorrect voltage level at Q16 & Q17, and is related to individual differences between these IC's. Correction is by changing one resistor value on the Control unit.

~~3.9K~~ → 1.8K

On the Control unit X53-1180-xx, replace R38 from 3.9k Ω to a 1.8k Ω resistor (RD14CB2E182J). No adjustments are required.
