## SERVICE BULLETIN

TS-930S Low RX Sensitivity

3.29.83

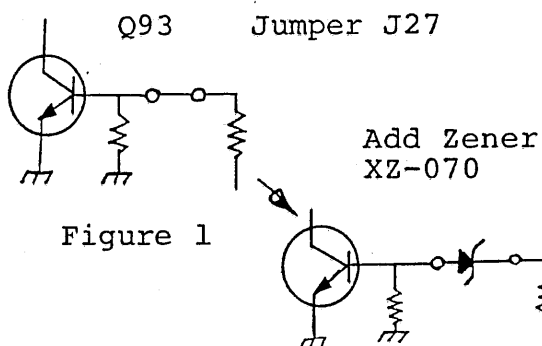
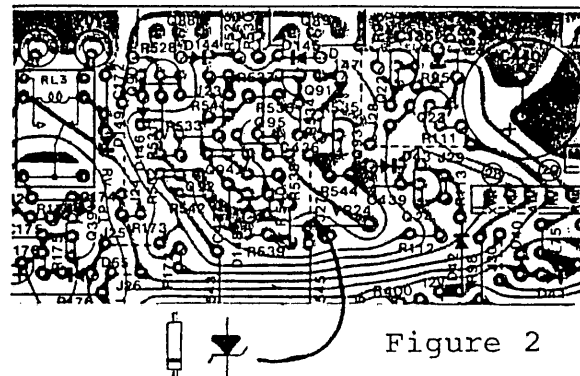
A loss of receiver sensitivity (6-30db) may be caused by shorted switching diodes in the Signal Unit (X57-1000-XX). The following procedure will increase the capability of the unit to withstand high RF voltage levels.

1. Replace Signal unit jumper J27 with an XZ-070 zener diode. (PCB coordinate C-1, see figure 2.)
