SERVICE BULLETIN

SUBJECT
TS-930S SERVICE NOTES ON AT-930DATE
8-23-83

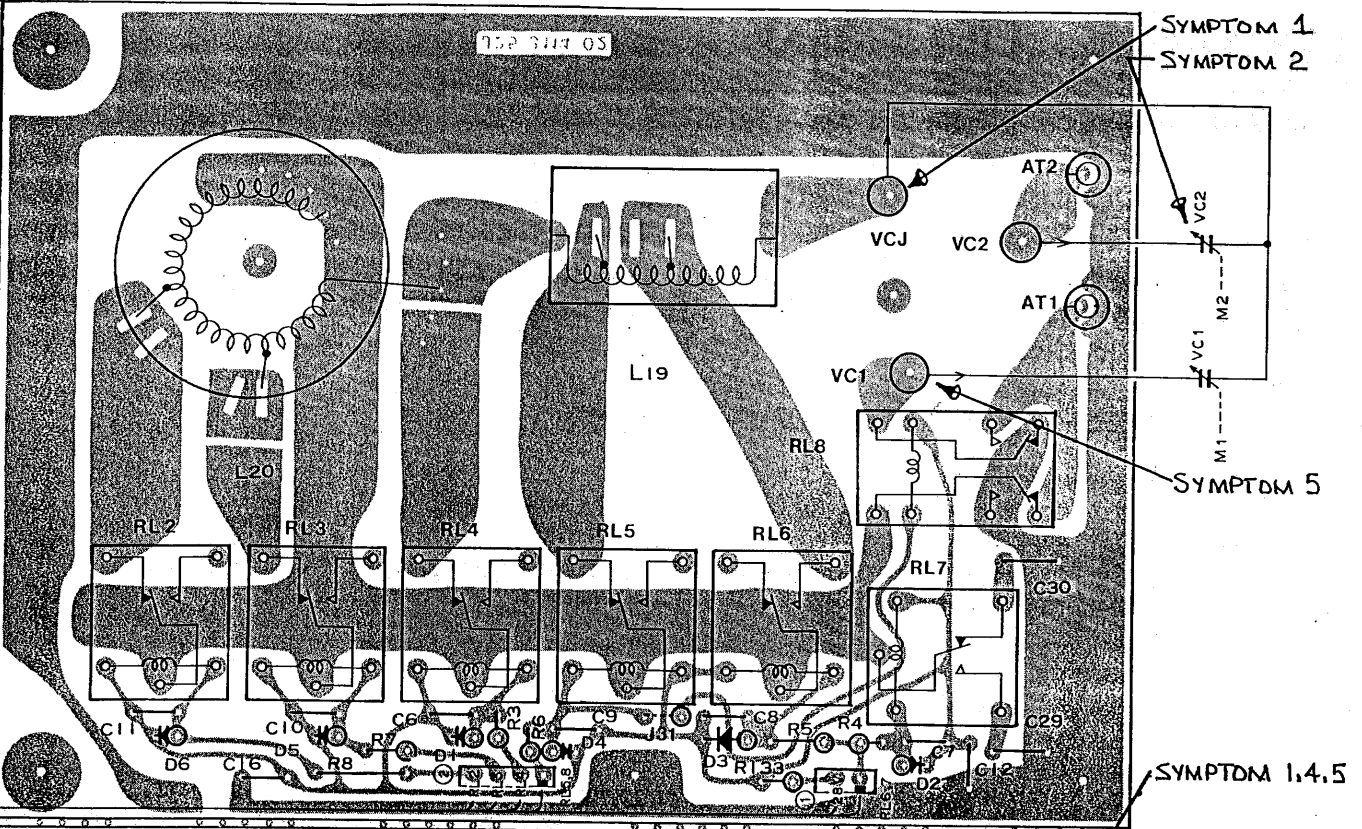
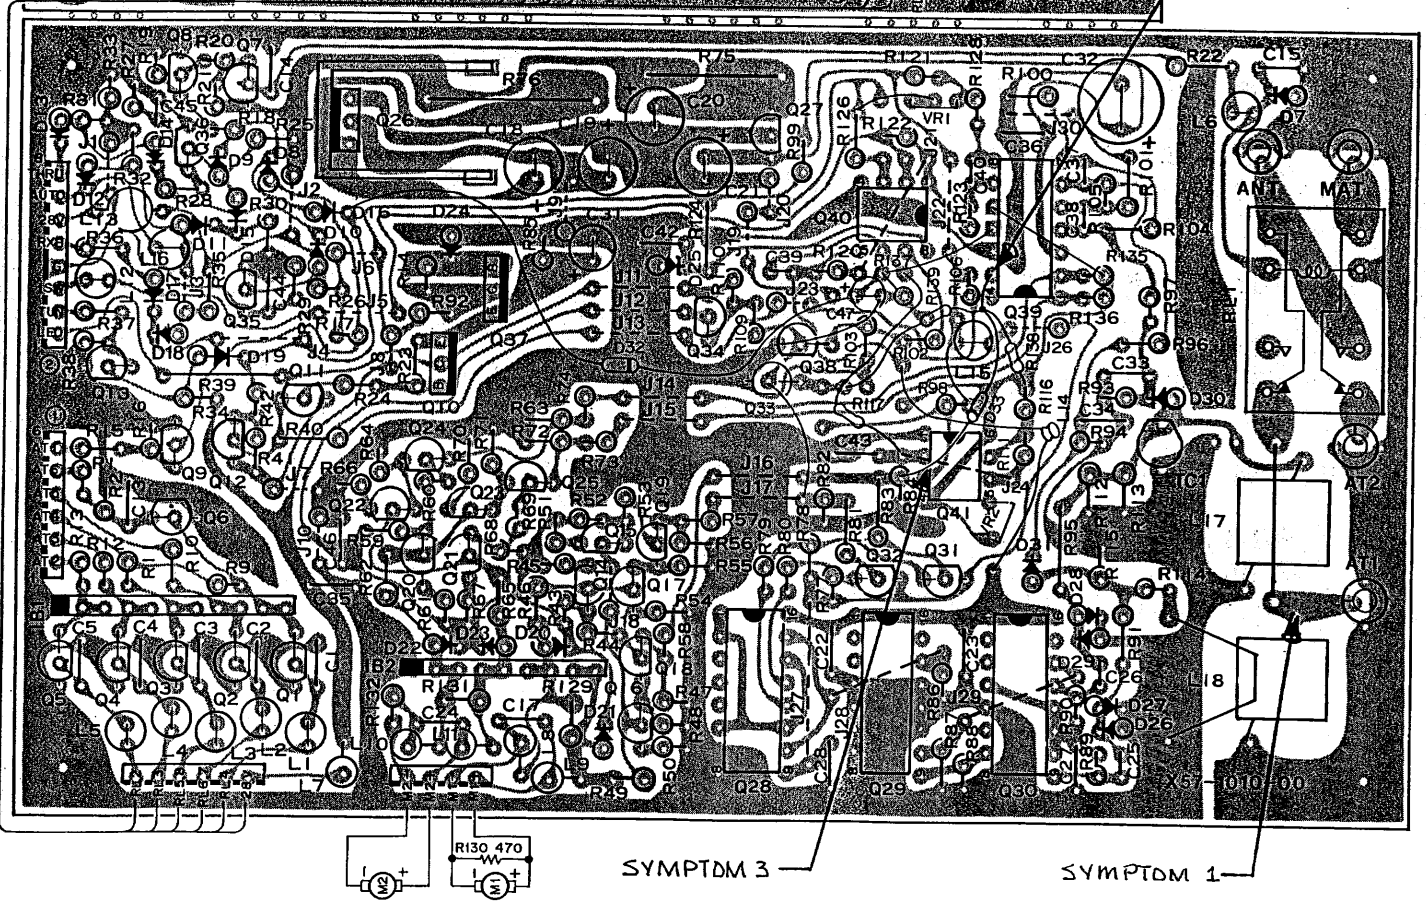
AT UNIT (X57-1010-00) Component side view

- a. Cold solder joint of plated VCJ wire.
- b. Cold solder joint of L18 lead.
- c. Cold solder joint of the wire between pin 13 of Q39 and R139, D33 and R138.

The rotor of VC2 contacts (shorts against) the stator.

Cold solder joint between D33 and R84.

The wire from R138, R139 and D33 may touch Q39 pin 14.

The wire from R138, R139 and D33 touches Q39 pin 14 and the foil is broken around VC1.
