## SERVICE BULLETIN

TS-430S INTERMITTENT PLL UNLOCK IN FM/AM

10-17-84

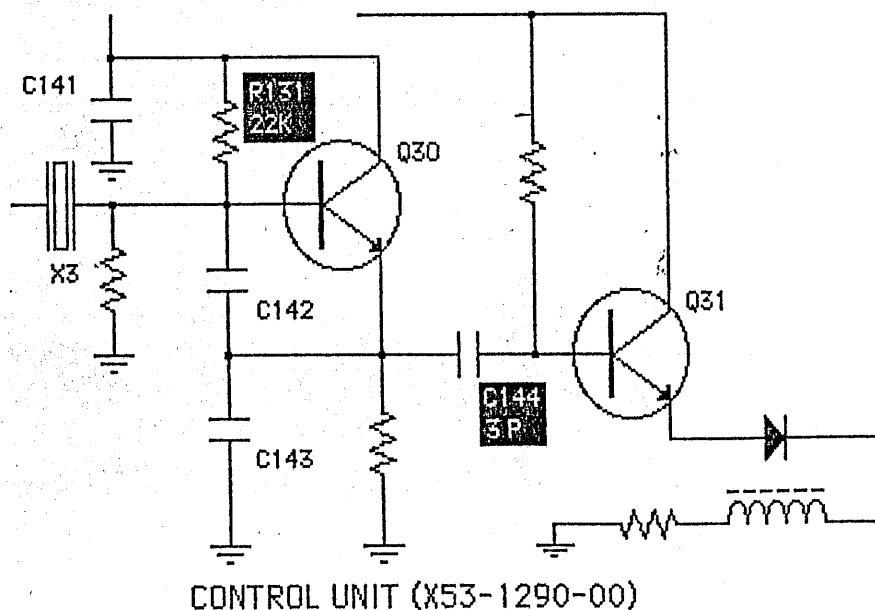
Some owners of the TS-430S have reported intermittent loss of Transmit and Receive when operating in the FM or AM modes, along with a loss of the Digital Display.

The cause of this may be due to a loss of the FM/AM Heterodyne Oscillator signal. Replacing the components listed below will correct most instances of this failure.

On the CONTROL UNIT (X53-1290-00) change R131 to a 22 K $\Omega$  1/4 watt carbon resistor (RD14CB2E223J), and change C144 to a 3 pF 25 v disc ceramic capacitor (CC455L1H050C).

No realignment is required.
