SERVICE BULLETIN

TM-411 LOW/NO RECEIVER SENSITIVITY

2-14-85

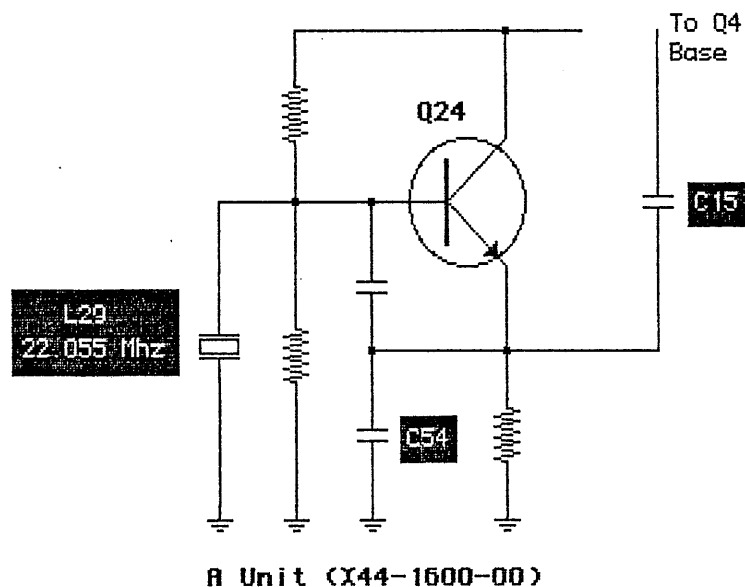
Some users of the TM-411 have reported a loss of receiver sensitivity. This may occasionally be traced to a loss of oscillation in the 2nd Oscillator, L29, on Unit A. Changing the below listed parts should correct any loss of sensitivity due to problems in the 2nd Oscillator.

On A UNIT (X44-1600-00) change the following parts:

XTAL L29 from L77-0870-05 to L77-0873-05

C15 from CC45CH1H020C to CC45CH1H1R5C (1.5 pF)

C54 from CC45CH1H120J to CC45CH1H330J (33 pF)
