SERVICE BULLETIN

TS-430S PLL UNLOCK AT HIGH TEMPERATURES (REVISION)

9-14-85

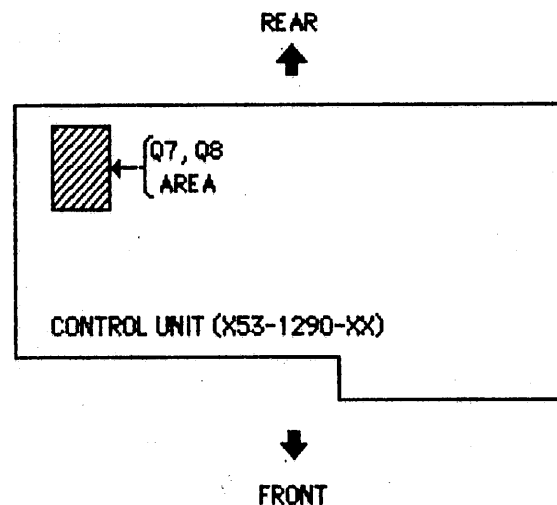
This service bulletin supercedes bulletin 891, which concerned low input levels to IC-16 as the radio warmed up. This bulletin incorporates information contained in Bulletin 891 plus additional information.

Check transistor Q8. If it is not a 2SC1815(Y) change it to this type (Serial numbers 408XXXX-509XXXX).

For serial numbers before 408XXXX change R29 to 820.0 Ω and C41 to 100 pF.

In addition to the changes listed above check for the following signals, (You must check these at a dial frequency of exactly 14.000.000 Mhz):

TP-1 6.0 volts (L-18 is the adjustment)

TP-2 70 Mhz

TP-3 45.3 Mhz

TP-4 6.35 volts (L10 is the adjustment)
