SERVICE BULLETIN

AMATEUR RADIO

TS-940S PLL UNLOCK

10-18-85

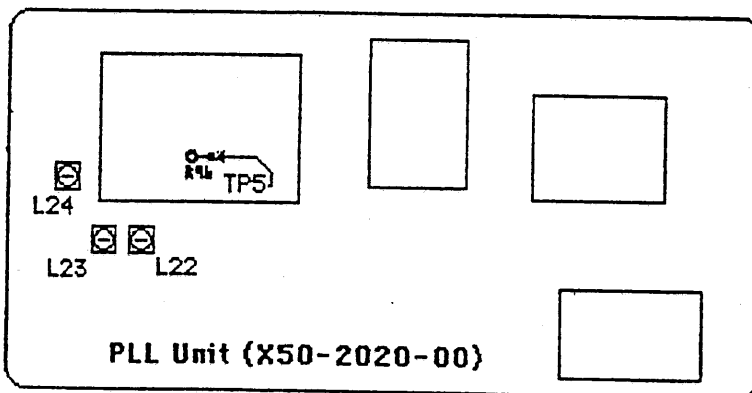
On the PLL Unit (X50-2020-00)

Some users of the TS-940S have reported a blanking of the display accompanied by a loss of transmit and receive. Readjustment of the PLL unit will correct this tendency.

1. Set the Dial frequency for approximately 1.8 Mhz (inside the band).
2. Using an RF probe at TP #5 adjust L22, L23 and L24 for a maximum reading on the meter. You should see approximately 250 mV.
3. Adjustment of L24 will produce the greatest change, which may be up to a 90° adjustment from its present position.
