SERVICE BULLETIN

AMATEUR RADIO

TS-430S LOW/INTERMITTENT RX

10-18-85

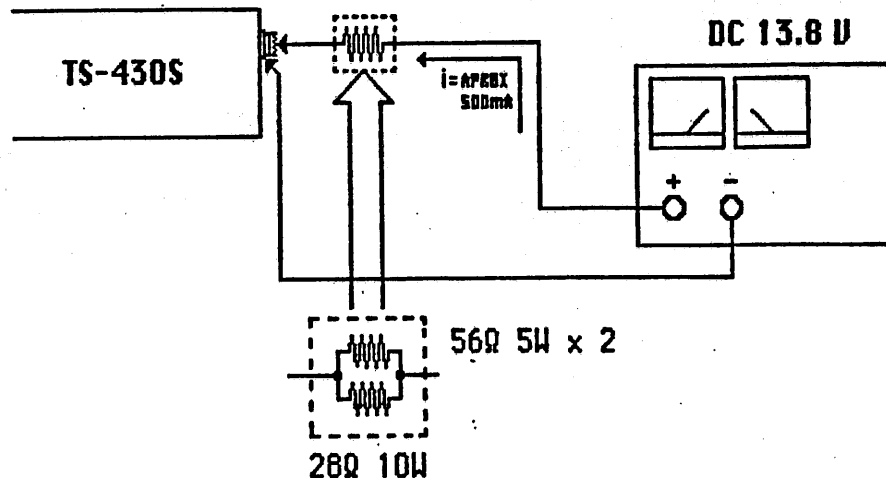
Low or intermittent receive on the TS-430S may be caused by a poor contact on one or more of the LPF relays. In most cases the following procedure will correct this problem without having to replace relays. The procedure has two steps, first initial cleaning of the contacts by passing a relatively high current thru them (about 500 mA), and then installing a contact maintenance circuit that will apply a relatively low current (about 8 mA) whenever a new band is selected.

1. Press and hold the "UP" bandswitch of the TS-430S (ensure the 1 Mhz switch is ON).
2. Apply 13.8 vdc to the antenna terminal thru a 28 Ω, 10 W resistor for approximately 1 minute. This will cycle thru all the relays and burn any oxidation/contamination from the contacts.
