903

SERVICE BULLETIN

TR-2600A PLL UNLOCK

1-14-86

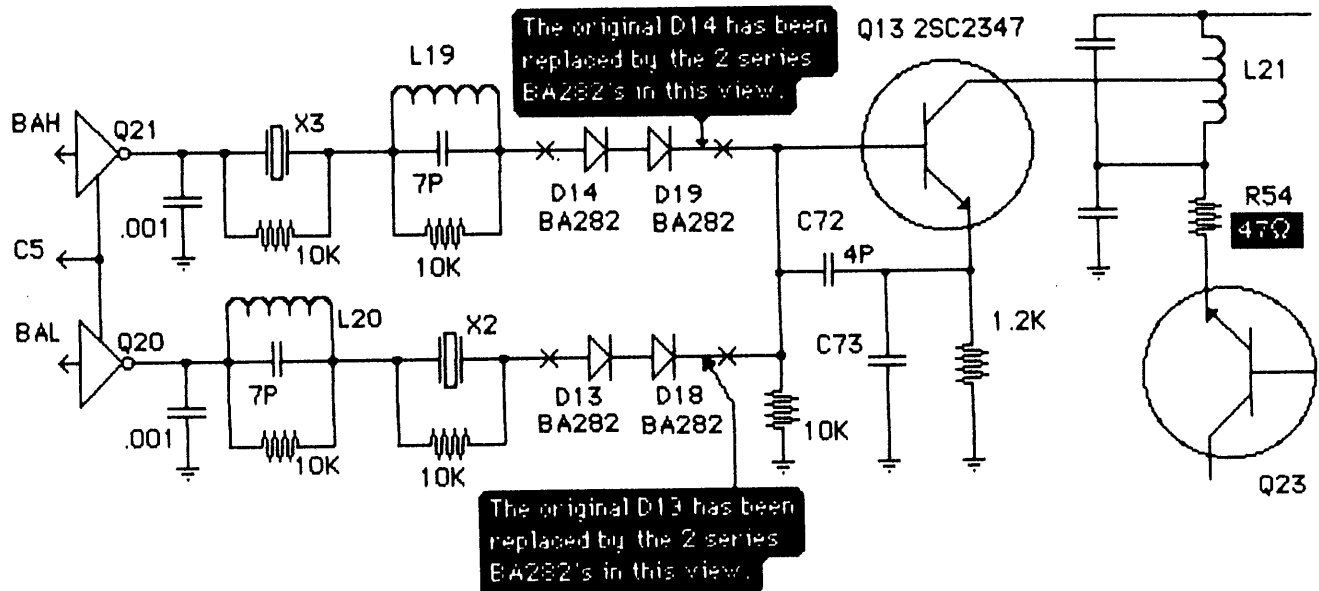
Some cases of PLL unlock on the TR-2600A may be caused by a failure of the crystal oscillator circuit X2, X3, and Q13. This may be corrected by performing the following changes.

Replace Diodes D13, and D14 (MA856) with a series pair of BA282's as shown in the diagram below. Also change resistor R54 to 47Ω as shown.

BA-282 diode.....4 each.
47 Ω Chip resistor (RD73FB2A470J).....1 each.
