SERVICE BULLETIN

TM-2550 DCL CALL SIGN DATA

2-7-86

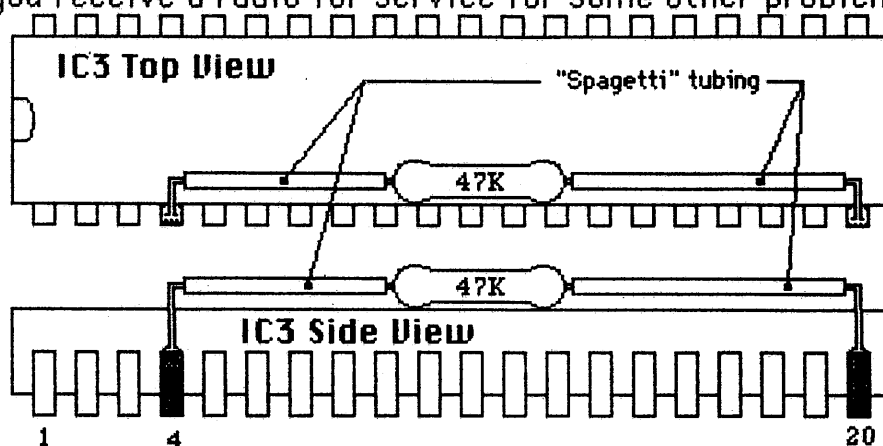
Some owners of the TM-2530/2550/2570 have reported a loss of the DCL system call sign data when the power switch is turned off. The call sign data actually remains in memory but timing prevents its utilization in some radios. Adding the resistor shown in the accompanying diagram corrects this problem.

If you receive a radio that exhibits this symptom add the resistor to IC3 the Slave CPU on the control unit (X53-1440-XX). Cover the resistor leads with "spaghetti" type insulation. Adding the resistor to radios that do not have this symptom will not cause any problems, so you may wish to add the resistor if you receive a radio for service for some other problem.

Solder the 47K ohm resistor directly to pins 4 and 20 of IC3. Don't overheat or use too much solder. You must use an iron with voltage isolation on the tip!

Before soldering unplug the DC Power cable and antenna from the radio. When soldering to this IC you must use a soldering iron that provides voltage isolation on the tip since IC3 is a CMOS device and can be easily damaged by static electricity or voltage on your iron. Use normal CMOS precautions. One final precaution: Don't bridge any of the pins on the IC with excess solder!
