SERVICE BULLETIN

SUBJECT TM-2570 LOW TX POWER OUTPUT	DATE 3-18-86
--	-----------------

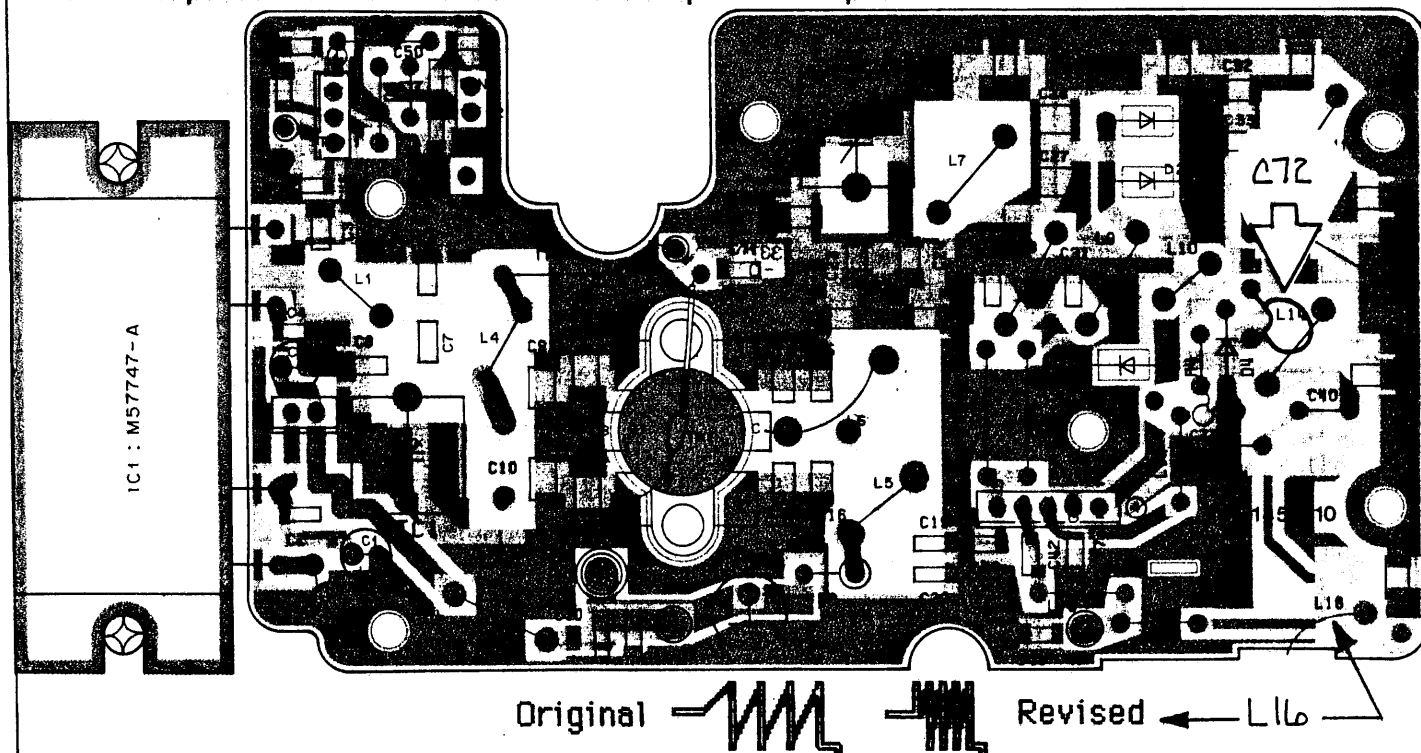
Some owners of the TM-2570 have reported low transmitter power when the radio is used with an antenna having reasonably low VSWR (1.5:1).

1. Remove the bottom cover on the heat sink.
2. Ensure that C72 is in the location indicated below. Note: Some radios may have C72 installed in the wrong position, check carefully.
3. Squeeze the coils of L16 closer together.
4. Make sure that C72 and L14 are as far away from each other as possible, move the capacitor, not the inductor.
5. Readjust VR1-VR4, according to the instructions provided in the Service Manual. The protection circuit (VR4), should be adjusted for 8A at 146.000 Mhz rather than the values indicated in the Service Manual. Change your Service Manual to reflect this value.
6. Replace the bottom cover to complete the procedure.
