SERVICE BULLETIN

AMATEUR RADIO

SUBJECT TS-940S ANTENNA TUNER RELAYS	DATE 4-4-86
---	----------------

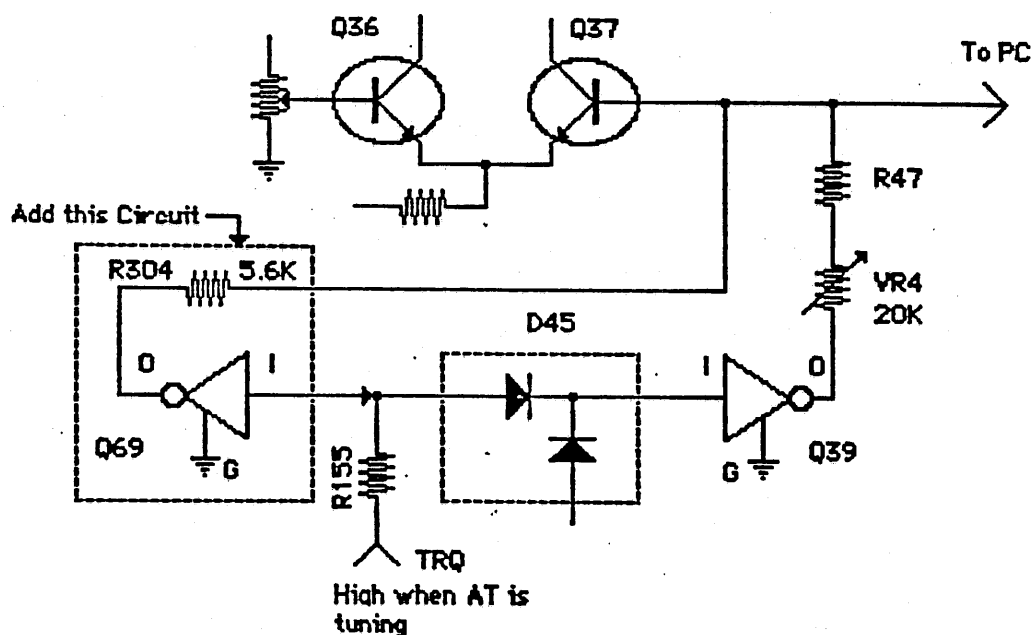
Occasionally during operation of the AT-940 a VSWR of greater than 1.5 to 1 might cause overloading of the relay contacts in the antenna tuner. This may be especially noticeable when switching BANDS, or if TUNING is performed too frequently. The following procedure should reduce or eliminate this tendency.

1. Add the circuit as shown below.
2. After the circuit has been installed adjust VR4 for a 10-15 watt output when the antenna tuner operates.
