## SERVICE BULLETIN

AMATEUR RADIO

SUBJECT	DATE
TS-940S PLL UNLOCK	4-8-86

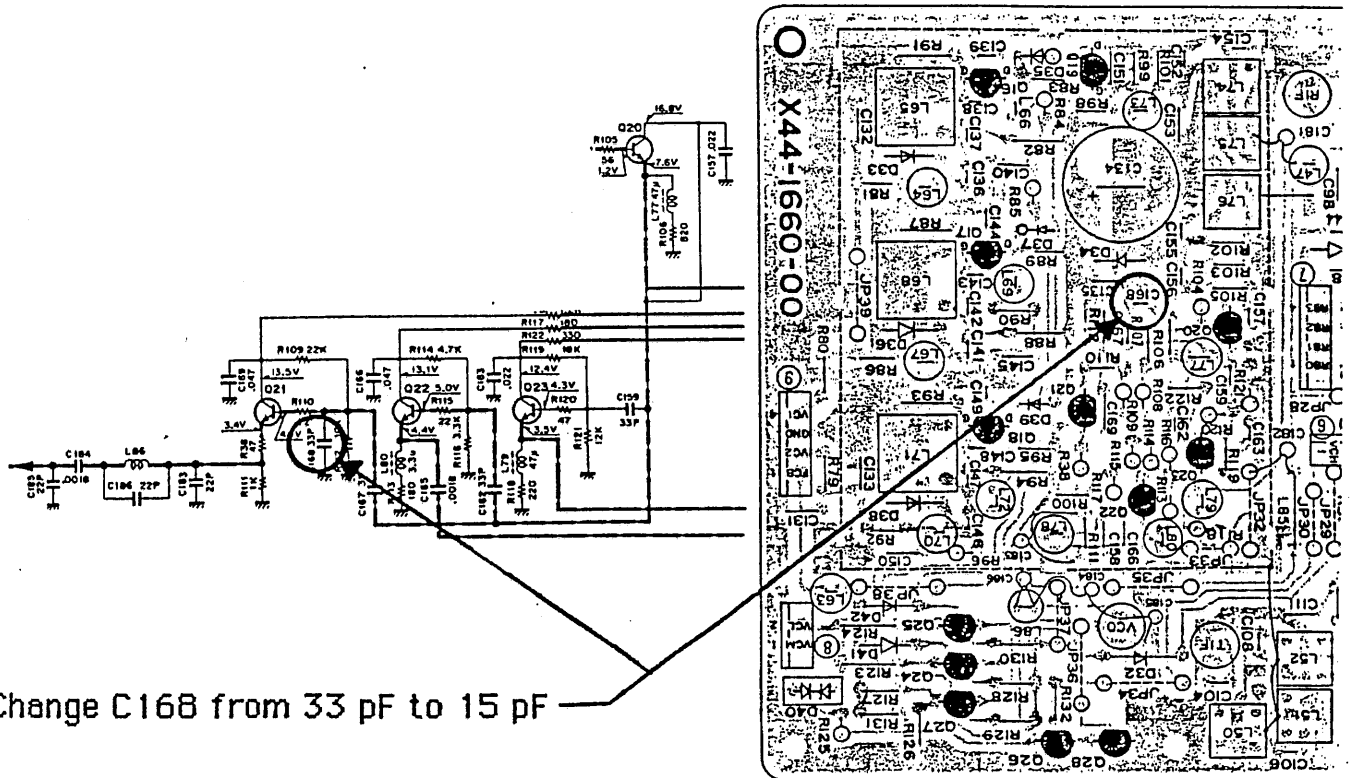
Reports of a PLL Unlock on the lower frequencies may be due to low VCO levels. The following change will increase the VCO level and should prevent reoccurrence of this symptom.

C168.....change to 15 pF 50 v (CC45SL1H150J)

1. On the RF Unit (X44-1660-00) change C168 from a 33 pF capacitor to a 15 pF 50 v capacitor.
2. Readjust the VCO BPF (RF unit L74-76) according to the instructions contained in the TS-940S service manual.
