KENWOOD

SERVICE BULLETIN

PS-50 IMPROVED VOLTAGE SURGE PROTECTION

5-23-86

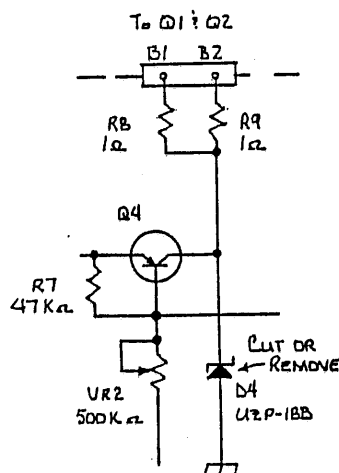
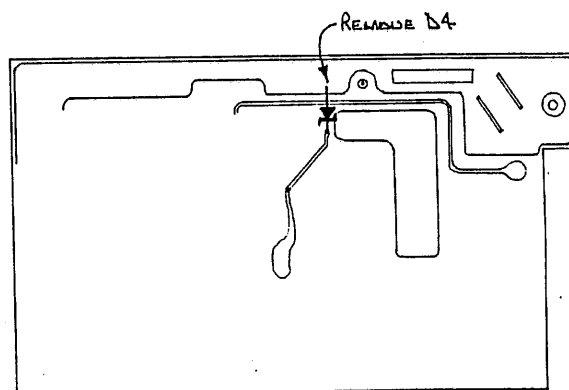
AVR UNIT (X43-1520-00) Component Side

We have received a few reports regarding the loss of transistor Q4, resistors R2, and R3, and zener diode D4 on the AVR UNIT. Apparently a voltage surge on the power input might cause D4 to short. If this occurs the surge current thru resistors R2 and R3 could be high causing the failure of the two resistors and Q4.

On the AVR UNIT (X43-1520-00) open or remove diode D4. The drawings below show the location of this component.

If you receive a unit with no output voltage check D4, R2, R3, and Q4. You should replace R2, R3, and Q4 if there is any sign of damage to any of these components.
