KENWOOD

SERVICE-BULLETIN

AMATEUR RADIO

<u> </u>					
SUB.	ECT								DATE	
	MC-040C	77.00	CADDIED	TIO.	MOTOR	DAMITO	IMPROVEMENT		1	3-2-87
1	15-3405	Y CO	CHULTER	TO	MOTOF	RAIIU	IMPROVEMENT	• •	ł	D 2 0 1
					······································				1

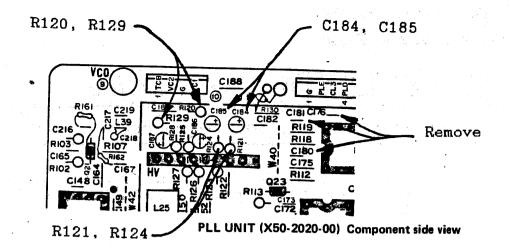
On the PLL UNIT (X50-2020-00) remove capacitors C176, C180, and C181. Change resistors R120 and R129 from 470 ohms to 3.3 K ohms. Change resistors R121 and R124 from 1 K ohm to 680 ohms. Change capacitors C184 and C185 from .22 uF to .33 uF 35V tantalum capacitors. Install C180 and C181 in the positions shown in the accompanying diagrams. The use of new capacitors is recommended to improve reliability, don't try to reuse the old capacitors! Capacitors C181 and C180 should be attached to the foil side of the PLL unit.

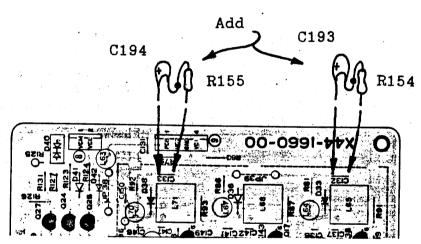
RF UNIT (X44-1660-00) Component side view

On the RF Unit (X44-1660-00) install the series RC circuits composed of R154 and C193, and R155 and C194, as shown in the accompanying diagrams. As the diagrams illustrate it is easiest to move C132 and C133 to the foil side of the board and install the series RC circuits on the component side.
