## SERVICE BULLETIN AMATEUR RADIO

SUBJECT TS-940S SSB TALK POWER IMPROVEMENT	DATE 7/22/87
---	-----------------

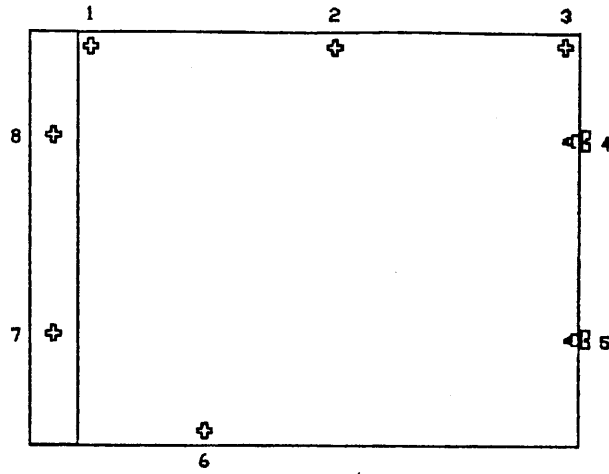
FIGURE 1

4. Locate transistor Q37 on the board (toward the back right hand side). The two capacitors are mounted on the foil side of the board underneath Q37.
5. To access the bottom of the board remove the 8 screws that mount the board and heat sink to the chassis (See figure 1).
