# KENWOOD

SB-925

## SERVICE BULLETIN AMATEUR RADIO

SUBJECT	DATE
TM-3530A NOISY TRANSMIT	11/02/87

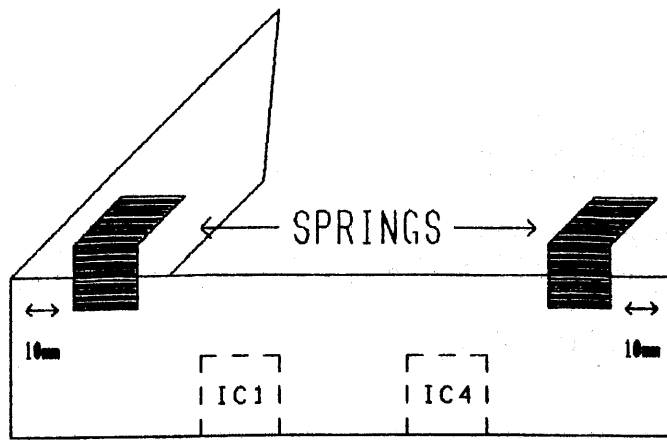
FIGURE 1

In some early model TM-3530A transceivers transmit noise may be generated as the unit warms up. The following procedure will reduce the noise.

1. Disconnect the power cord and antenna.
2. Remove the top and bottom covers.
3. Replace L3 on the Compound unit (part number L15-0308-05). Before soldering the coil to the board, place a drop of contact or silicon glue under the coil to prevent mechanical vibration.
4. On the Compound unit, solder two springs (part number G02-0550-04) to the heat sink as shown in figure 1. The springs must be mounted high enough to make firm contact with the top cover when installed.
5. On the PLL unit, solder a spring (part number F10-1206-04) to the TX VCO shield (see figure 2). The spring must make firm contact with the bottom cover when installed.

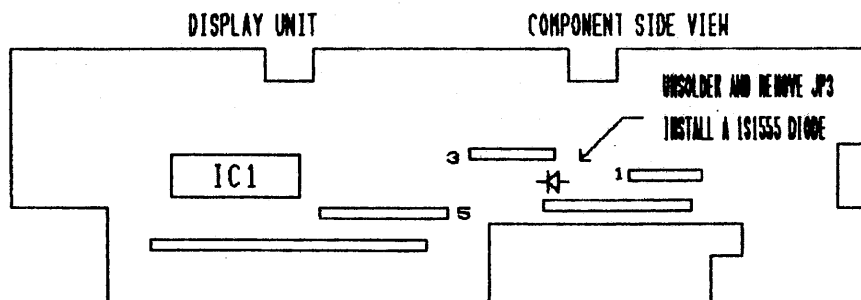
FIGURE 3

**CAUTION:** The next step requires complete disassembly of the front panel and Display unit. This step may be reserved for problem units.

6. On the Display unit, replace jumper JP3 with a diode (part number 1S1555) as shown in figure 3.
7. Reassemble the transceiver and test the modulation for correct adjustment:
  1. Apply a 1KHz, 50mV signal to pin 1 of the mic jack.
  2. Turn VR7 on the Compound unit fully CCW.
  3. Use a service monitor, linear detector, or deviation meter to measure the TX deviation at the antenna jack.
  4. Adjust VR5 on the compound unit for +/-4.5KHz.
  5. Reduce the mic signal to 5mV. Adjust VR7 for +/-3.0KHz.
