SERVICE BULLETIN AMATEUR RADIO

SUBJECT	DATE
TW-4100A REPEATER STOP SCAN ON THE UHF BAND	12-17-87

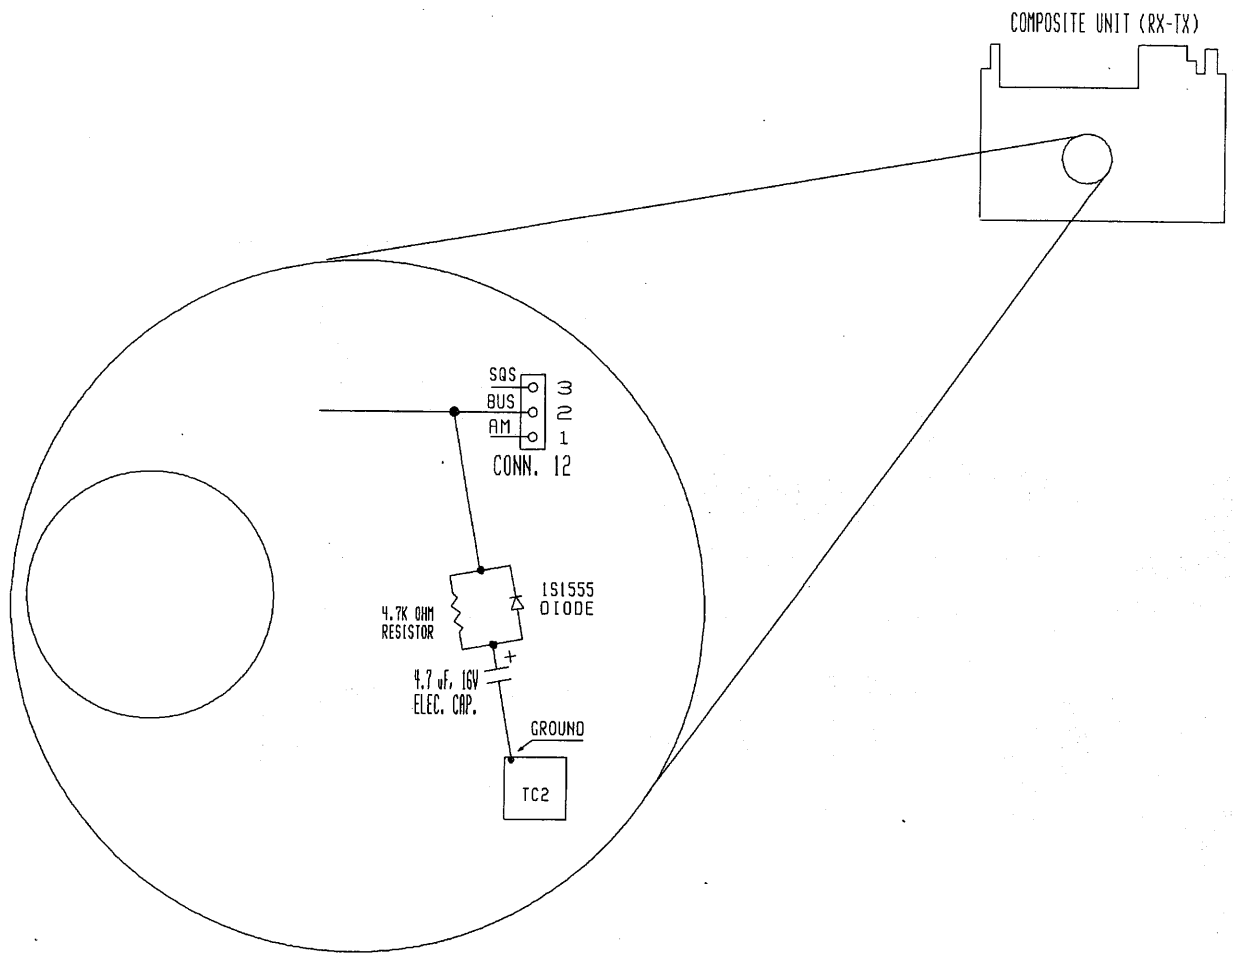
FIGURE 1

During repeater cross band operation, the TW-4100A may not detect a UHF signal while it is alternating between the two bands. This is due to the electric field generated by the strong UHF receiving signal causing the busy circuit to malfunction. The following modification will allow detection of the UHF signal.

4. Locate connector number 12 on the Composite unit (RX-TX) on the bottom of the transceiver.
5. Carefully strip 1/8 inch of insulation from the wire attached to pin 2 connector 12 approximately 1/4 inch from the connector (do not break the wire).
6. Solder the 3 components (listed above) between the wire and ground. A good ground location is the can around TC2 and L8.
7. Assemble the transceiver by reversing steps 1 - 4.
