SB-927R

## SERVICE BULLETIN AMATEUR RADIO

RC-10 ALTERNATOR NOISE

10/28/88

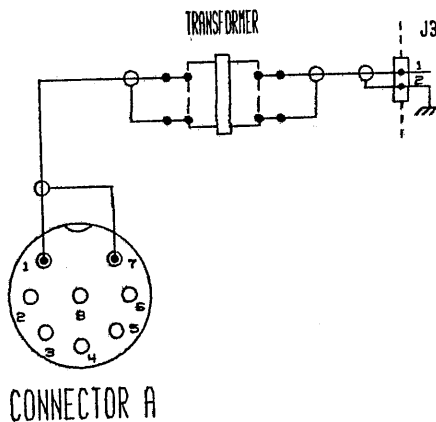
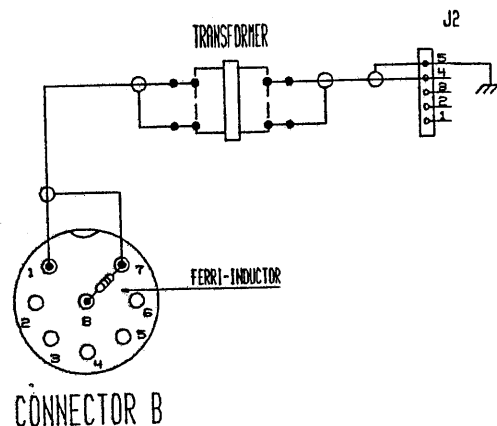
When two transceivers are connected to the RC-10, alternator noise may be induced in the mic circuits. The following modification will correct this condition.

1. Remove the base plate from the RC-10 (6 screws on the plate; 1 screw on the back panel).
2. Add the ferri-inductor between pins 7 and 8 of connector B as shown below.
3. Locate connectors J2 and J3 on the AF unit (X49-3010-XX B/3).
4. Add a transformer in each mic circuit as shown below.
5. Using double sided tape, secure each transformer to the side wall of the base.
