## SERVICE BULLETIN AMATEUR RADIO

SUBJECT TS-440S OPERATION WITH THE MC-85	DATE 01/20/89
---	------------------

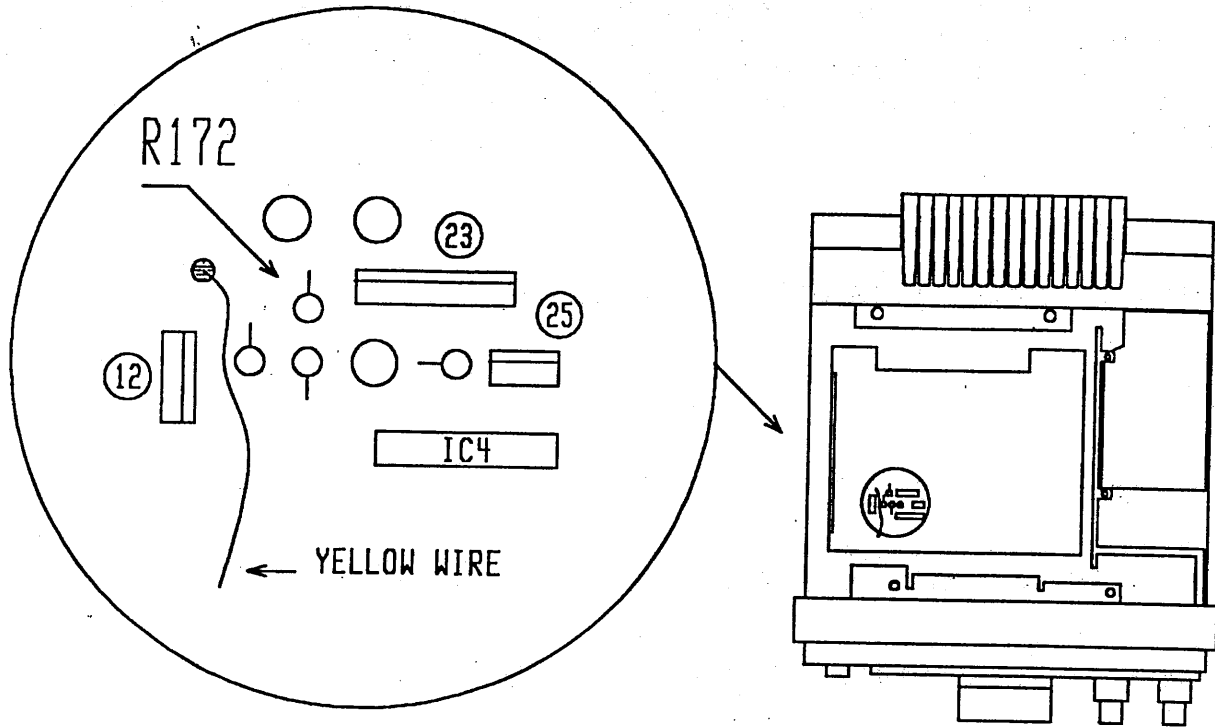
FIGURE 1

With some TS-440S transceivers, insufficient modulation may occur when the MC-85 compression switch is turned on. This may be caused by too much of a voltage drop across resistor R172 on the IF unit of the transceiver. If this is found to be the case, change the resistor from 1K ohm to 100 ohms.

1. Disconnect the power supply and antenna from the transceiver.
2. Using a #2 Phillips screw driver, remove the 9 screws from the top cover of the transceiver. Remove the cover and unplug the speaker wire.
3. Locate resistor R172 on the component side of the IF board (Figure 1).
4. Using a #1 Phillips screw driver, remove the 7 screws that secure the IF unit to the chassis of the transceiver.
5. Pull the board up and rotate it towards the front of the transceiver to expose the foil side of the board.
6. Desolder and remove resistor R172 from the board.
7. Install and solder the 100 ohm resistor in place of R172.
8. Assemble the transceiver by reversing steps 1 - 5.
