KENWOOD

SERVICE BULLETIN AMATEUR RADIO

į	SUBJECT	DATE	
	TS-950SD SPEECH PROCESSOR NOISE	01/12/90

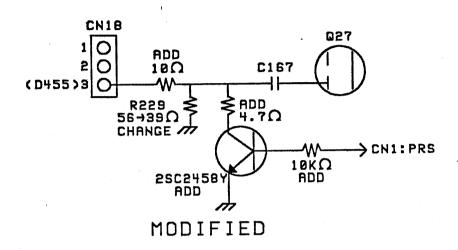
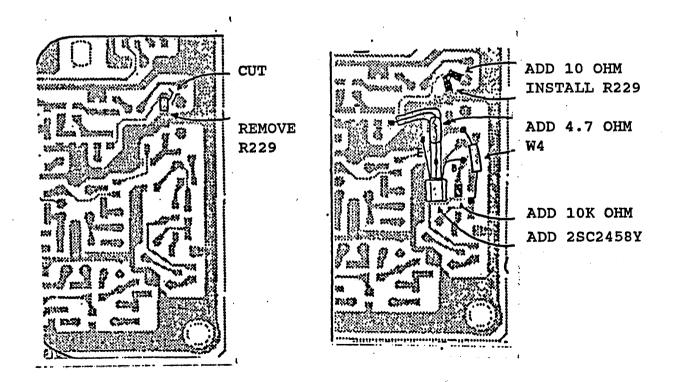
When the Processor-In control is set to some level below 10dB of compression, a crackling noise can be induced on the transmit signal. The following modification will reduce the noise. After the modification has been performed, the noise can only be heard when the Processor-In control is set too low to be functional.

- 1. Cut the foil between pin 3 of CN18 and chip resistor R229.
- 2. Desolder and remove R229.
- 3. Solder a 10 ohm chip resistor across the cut foil.
- 4. Solder a 39 ohm chip resistor in place of R229 (it will be slightly offset due to the installation of the 10 ohm resistor).

- 5. Solder a 4.7 ohm resistor to the collector of a 2SC2458(Y) transistor. Shorten the lead length to accommodate the following installation and insulate the leads with shrink tubing.
- 6. Solder the exposed end of the 4.7 ohm resistor to chip capacitor C167.
- 7. Solder the base and emitter leads as shown in the accompanying diagram.
- 8. Solder a 10K ohm resistor to the circuit as shown.
