SERVICE BULLETIN AMATEUR RADIO

SUBJECT TS-950SD RX DIGITAL NOISE	DATE 01/17/90
--------------------------------------	------------------

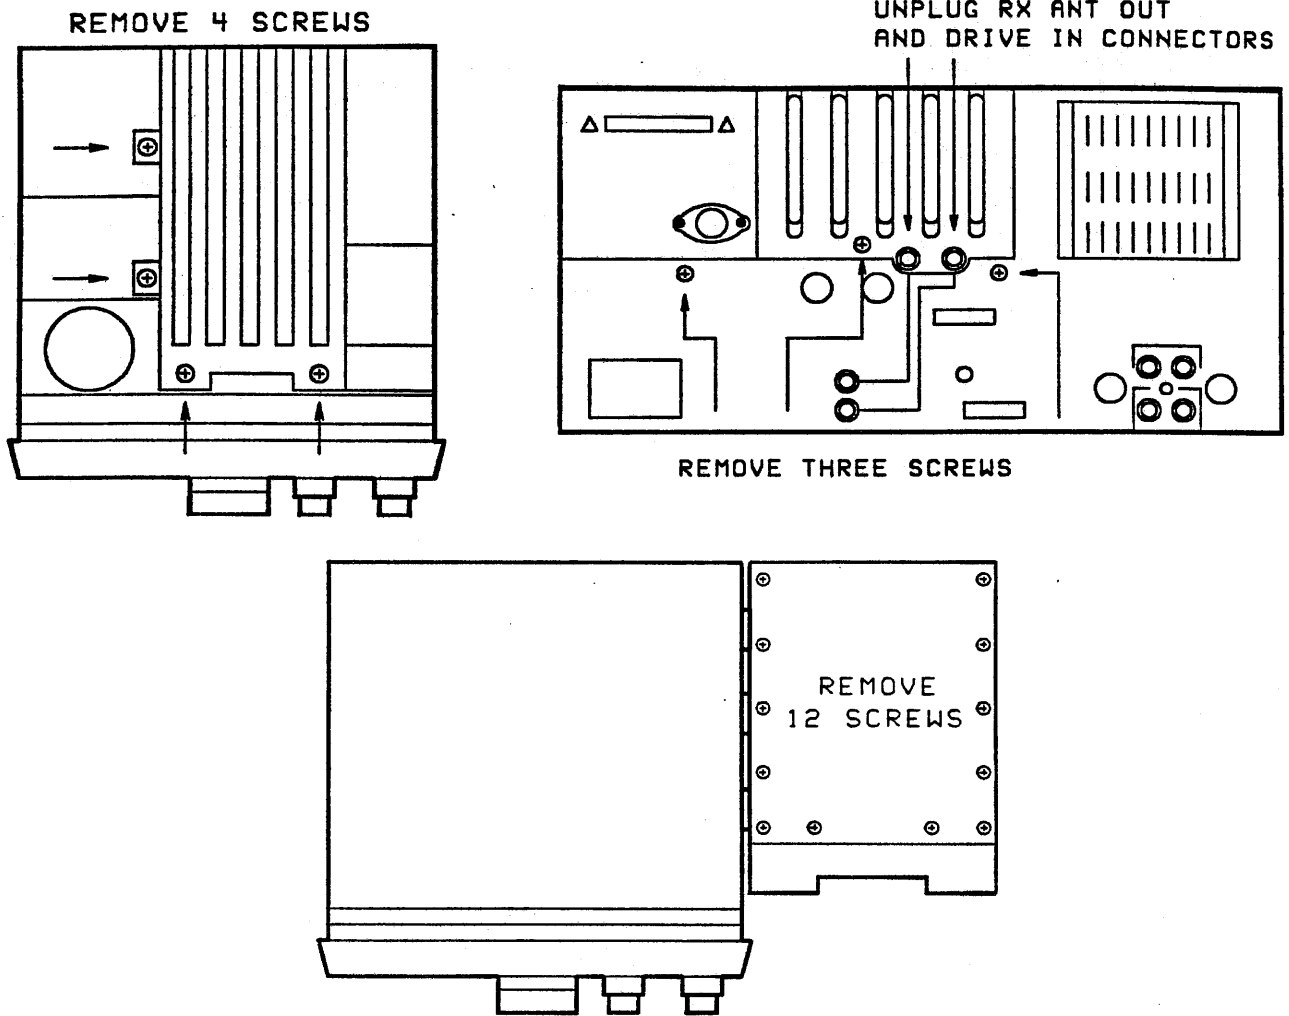
FIGURE 1

Some early TS-950SD transceivers may exhibit a low Signal to Noise ratio on ten and fifteen meters. In addition, rotating the encoder may allow the user to hear a crackling noise in his headphones. The following modification will correct this condition.

1. Disconnect the power cord and antenna.
2. Remove the top and bottom covers (18 screws).
3. Open the subchassis as shown in figure 1 (remove 4 top screws, remove 3 back panel screws, unplug the RX ANT OUT and DRIVE IN connectors).
4. Remove the cover from the subchassis (12 screws). FIGURE 1.
5. Remove the 9 screws from the Filter board.
6. Desolder the antenna connector wires at the antenna connector. Do not damage the surge absorber.
7. Rotate the Filter unit to expose the foil side of the board. Disconnect coax cables as necessary to rotate the board and remove the mesh plate as the board is rotated.
8. Cut the two ground foils as shown in figure 2.
9. Assemble the transceiver by reversing steps 1 - 7. Remember to install the mesh plate, resolder the antenna connector, and plug in the two connectors on the back panel.
