SERVICE BULLETIN AMATEUR RADIO

SUBJECT TM-731A/631A 144MHZ FINAL BOARD C17 CHANGE	DATE .08/08/90
---	-------------------

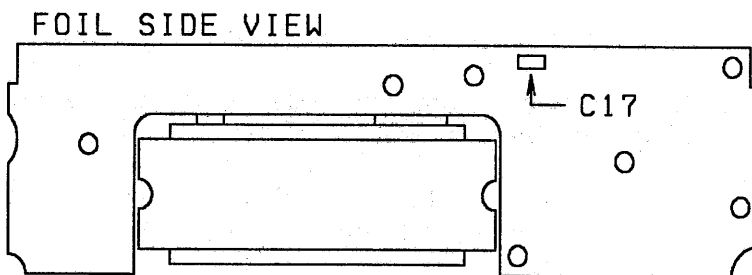
FIGURE 3

Bypass capacitor C17 on the 144MHz Final board has been changed in production from a "flat package" chip capacitor to a "cylindrical package". The change prevents the capacitor from fracturing. If C17 fractures, the output of the power module can burn C17, R11, and L6. Additionally, Q1 on the TX/RX (144MHz) board may be damaged.

C17 should be changed as a part of routine maintenance when a TM-731A/631A is received for service. The new style capacitor part number is CK41FY1E102M. For field service, a 0.001uF, 25V disc ceramic capacitor can be used.

1. Disconnect the power supply and antenna.
2. Remove the top cover. Do not damage the speaker wires.
3. Remove the shield plate from the VHF Final unit (4 screws). **Figure 1**
4. Remove the 7 screws that secure the final board to the chassis. **Figure 2**
5. Remove the 2 screws that secure the power module to the chassis. **Figure 2**
6. Remove the 2 screws that secure the VHF antenna coax to the heat sink.
7. Desolder the center conductor and shield of the VHF antenna coax from the final board and pull the coax out of the heat sink. **Figure 2**
8. Desolder the terminal next to pin 3 of the power module. **Figure 2**
9. Rotate the board toward the front of the transceiver to expose the foil side of the board.
10. Inspect the solder at the terminals the antenna coax was soldered to. They may need to be resoldered.
11. Replace C17. **Figure 3**
