# KENWOOD

ASB-993

## SERVICE BULLETIN

TH-27A/E Low TX Power

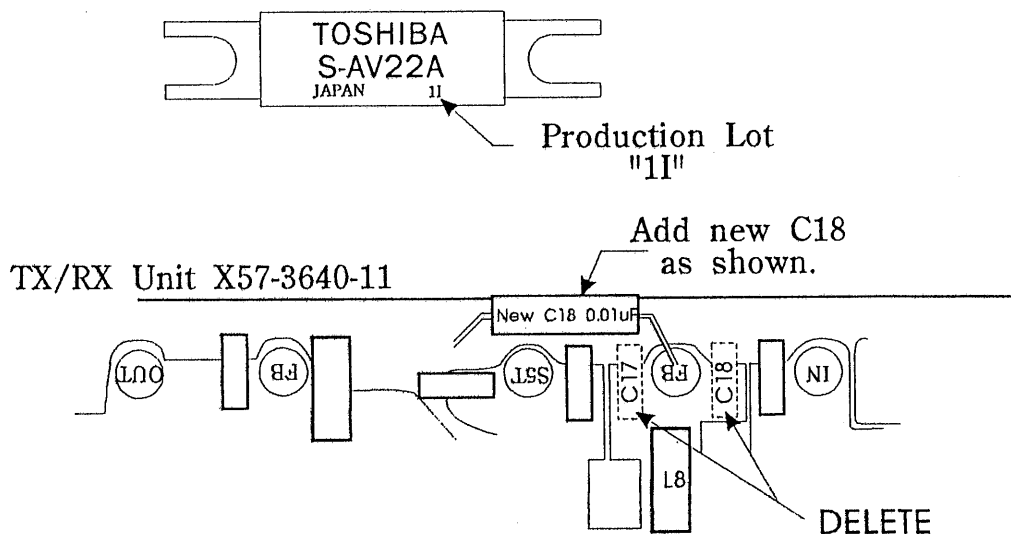
We have noticed some variation in the output power provided by Toshiba S-AV22A power modules with a production code of "11". Modules with this production code might exhibit low or no transmitter output power. This procedure will correct this problem.

1. Remove chip capacitors C17 and C18 from the TX-RX Unit (X57-3640-11.)

2. Install the new axial lead capacitor as shown in the accompanying diagram.

Note: Deleting C17 and C18 alone will not correct this symptom. The new C18 will be used to stabilize circuit performance. Deleting C17 alone will not cure the symptom.
