ASB-995

SERVICE BULLETIN

TS-450/TS-690 Calibration Cable Change

May 11, 1992

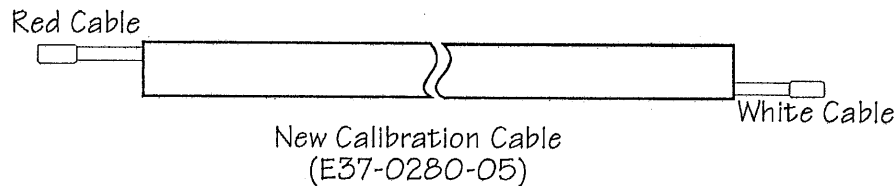
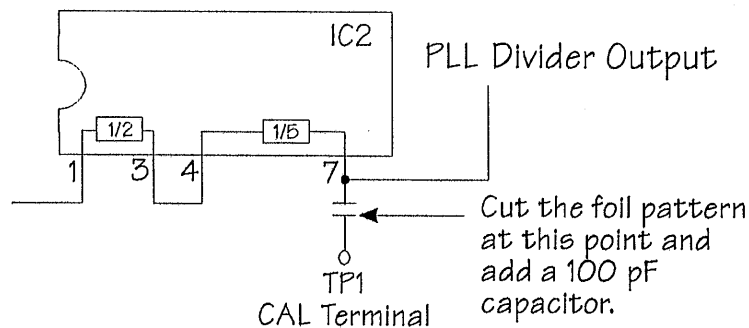
The TS-450/690 may not calibrate properly against WWV (JJY) when using the calibration cable that is supplied with early versions of these sets, (Serial numbers below 311XXXX) and when an antenna that is shorted for DC is used. A dipole with a balun is a prime example of a DC shorted antenna. This failure is antenna specific; i.e. multiband beams and other similar antennas do not cause this failure.

A new calibration cable is available that provides proper DC isolation. Failure to use the new style cable will result in a PLL unlock condition when calibration is attempted. A temporary countermeasure that can be used until the new cable is obtained is to use a two conductor shielded wire. A minor circuit modification that adds a 100 pF isolation capacitor should also be performed. Please refer to the diagrams below for modification notes.

E37-0280-05	Calibration Cable Assembly	1 Ea.
CK73FCH1H101J	100 pF Capacitor	1 Ea.
