# KENWOOD

ASB-1001

## Service Bulletin

**Subject:** TS-950SDX Distorted DRU-2 TX Audio  
1992

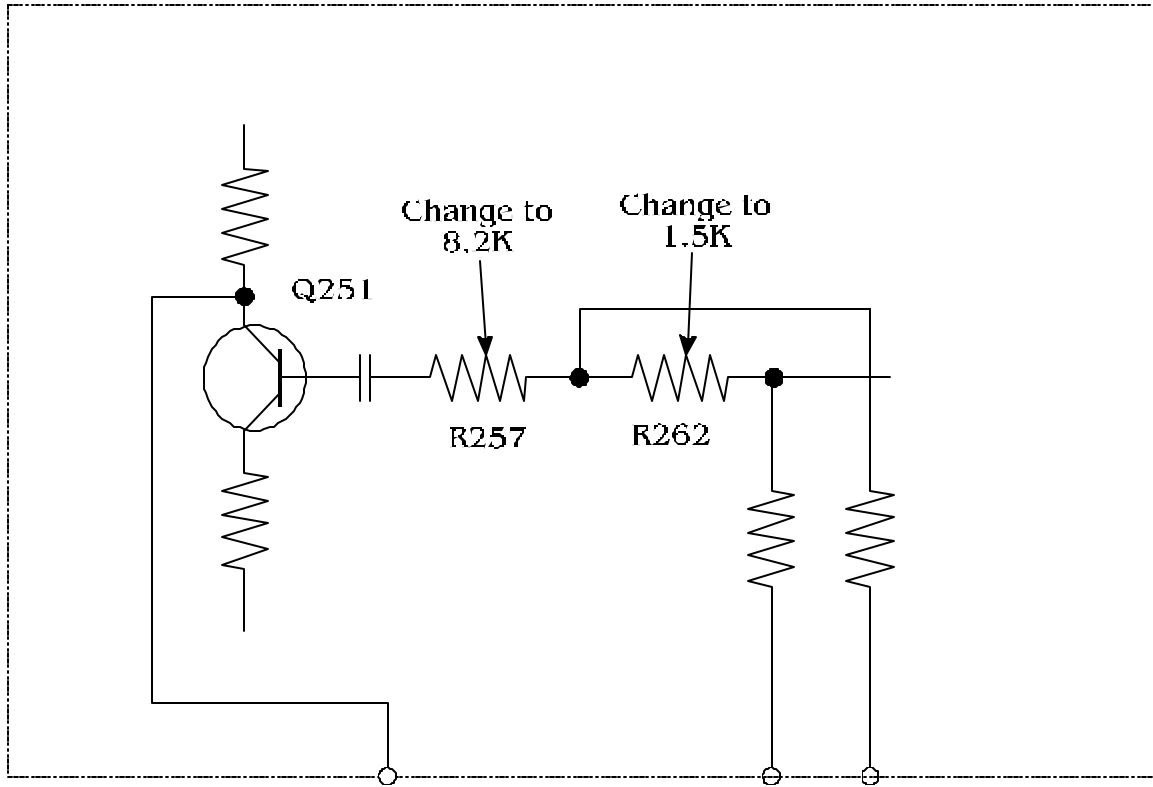
## MIC AMP (X59-3710-01)

We have received several reports of minor distortion of the DRU-2 transmitted audio when used with the TS-950SDX. Recordings made from incoming received sources do not appear to be distorted.

**Cause:** This characteristic is caused by an impedance mismatch between the DRU-2 output and the input of the microphone amplifier circuit in the TS-950SDX. The following modification will correct/improve this characteristic.

1. Change chip resistor R257 from 4.7K to 8.2K ohms (RK73FB2A822J).
2. Change chip resistor R262 from 4.7K to 1.5K ohms (RK73FB2A152J).
