ASB-1010

Service Bulletin

Subject: AT-50 Blows ACCY Fuse in TS-50S

Date: April 30, 1993

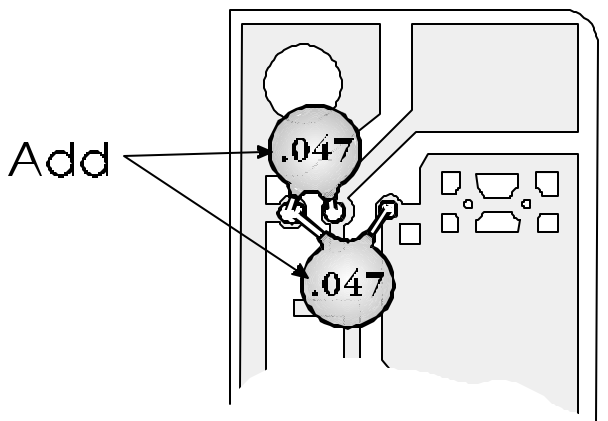
X53-3470-00 D/4
Foil Side View

Attempting to tune the AT-50 when it is connected to an antenna with a relatively high SWR value might cause the ACCY fuse to open in the TS-50S. This change will correct this tendency.

1. Remove the top cover from the antenna tuner.
2. Locate X53-3470-00 D/4 (It is attached to the top left side of the chassis with the foil side up.)
3. Add the two .047 μ F capacitors as shown in the drawing below.
4. Replace the top cover.
