ASB-1011

## Service Bulletin

**Subject:** TM-732A Low Cross-band Repeat Audio

**Date:** May 3, 1993

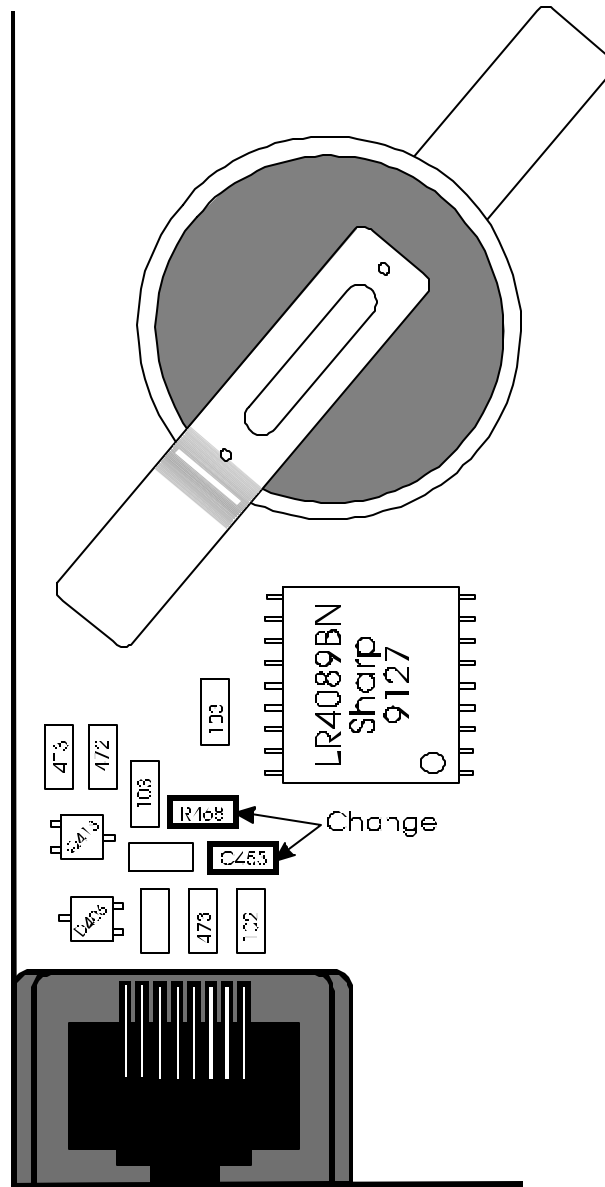
**X57-4000-11 C/4**  
**Foil Side View**

Improper DTMF operation and low microphone audio have been reported by several owners of the TM-732A when the units are operated in the Cross-band repeat mode.

1. Detach the front panel assembly from the chassis.
2. Remove the top and bottom covers from the chassis.
3. Remove the small countersunk Phillips head screws from the sides of the chassis. These are used to secure the two brackets that holds the plastic front cover to the chassis. Gently pull the plastic cover assembly forward and remove it from the chassis.
4. The TX/RX Control unit should now be visible on the front of the chassis assembly.
5. Replace R468 and C453 shown in the accompanying diagram.
6. Reverse steps 1 through 3 to reassemble the radio.
