KENWOOD

ASB-1013

Service Bulletin

Subject: TH-78A/E Left Encoder Inoperative
1993

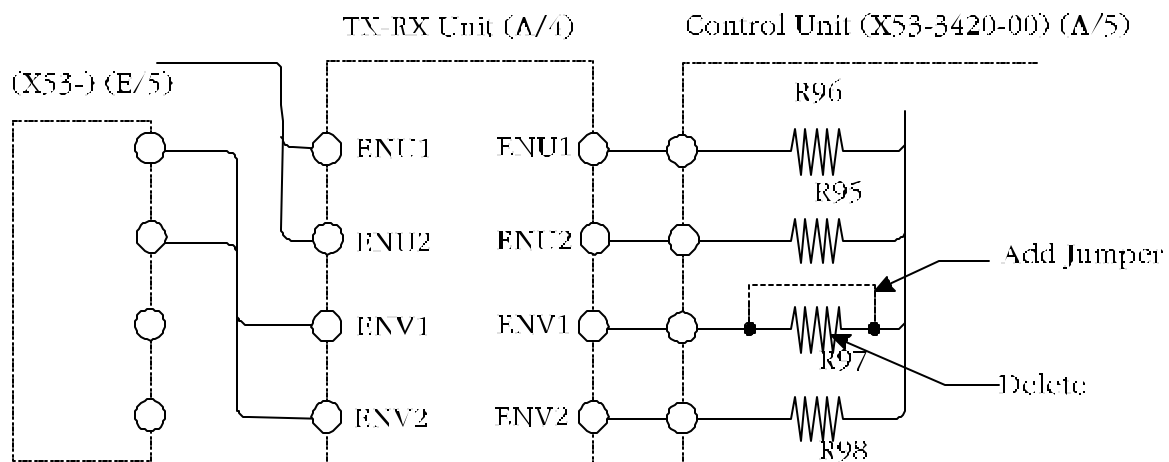
The left encoder on the top panel does not work. This symptom usually occurs when the unit is reassembled after service.

If the front panel is removed without removing the top panel the Control unit might come in contact with the encoder mounting hardware. This causes chip resistor R97 to be sheared from the board.

Delete chip resistor R97 from the control unit and add a short jumper wire in its place. Resistor R97 was used to prevent feedback during transmit. It has been confirmed by our engineering staff that the performance of the circuit will not be adversely affected by this change.
