# KENWOOD

ASB-1014

## Service Bulletin

**Subject:** TM-732A/E Noise at Squelch ON/OFF  
1993

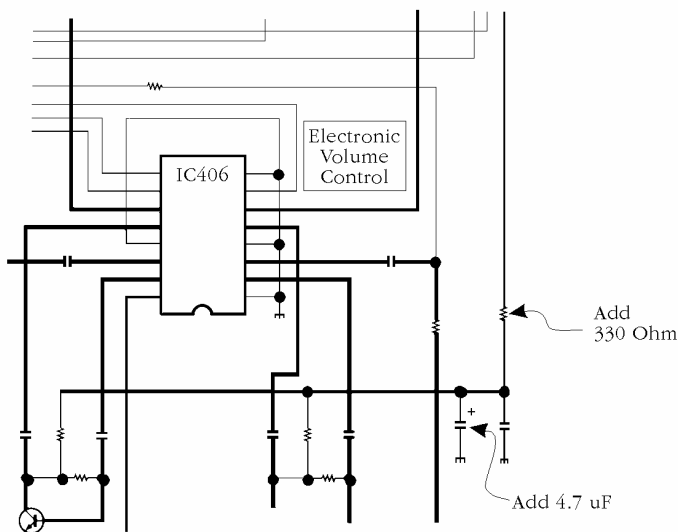
While receiving a signal on one band a noise is heard in the speaker whenever the squelch on the other band opens or closes.

Add a 330 ohm resistor and 4.7 uF capacitor to the 5C line in the control unit (X57-4000-11 C/4). Cut the 5C line and add the 330 ohm resistor in series.
