ASB-1022

## Service Bulletin

**Subject:** MC-44/MC-44DM Intermittent Modulation  
1993

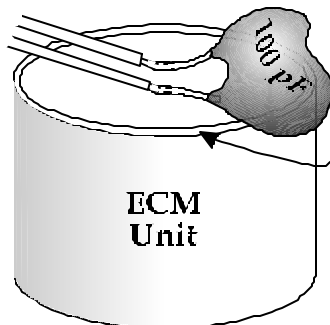
The lead wire of capacitor C8 might be shorting out against the case of the ECM unit.

Make sure the leads of C8 100 pF capacitor do not touch the ECM case.

Re-install the capacitor so that the leads cannot touch the ECM case.
