ASB-1025

Service Bulletin

Subject: AT-50 Blows ACCY Fuse in TS-50S (Part 2) **Date:** June 25, 1993

(Supercedes ASB-1010 dated April 30, 1993)

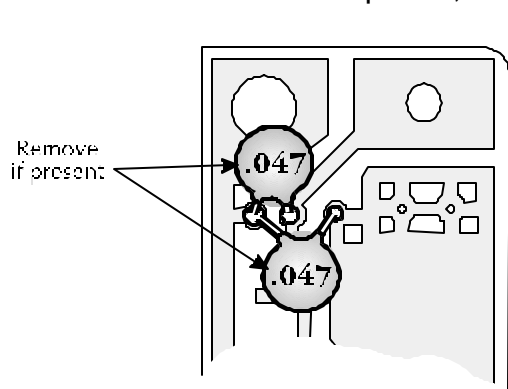
**X53-3470-00 D/4
Foil Side View
Figure 1**

Attempting to tune the AT-50 when it is connected to an antenna with a relatively high SWR value, especially on the 3.5 MHz band might cause the ACCY fuse to open in the TS-50S.

1. Remove the top and bottom covers from the antenna tuner.
2. Locate X53-3470-00 D/4 (It is attached to the top left side of the chassis with the foil side up.)
3. Remove the two .047 μ F capacitors shown in figure 1 if they are present.
4. Cut the foil and add one of the toroidal inductors as shown in figure 2.
5. Turn the tuner over and locate capacitor C123 and C124, as shown in figure 3.
6. Move the capacitors (or add new capacitors) to the locations shown in figure 3.
7. Cut the foil path and add the remaining toroidal inductor as shown in figure 3.
8. Remove Jumper W106 as shown in figure 3. (Note remove the jumper from the component side of the board.)
9. Add a jumper from the ATG foil to W104 as shown in figure 3.
10. Replace the top and bottom covers.
