# KENWOOD

ASB-1031

**Subject:** SMC-34 Distorted/muffled transmit audio

**Date:** July 20, 1993

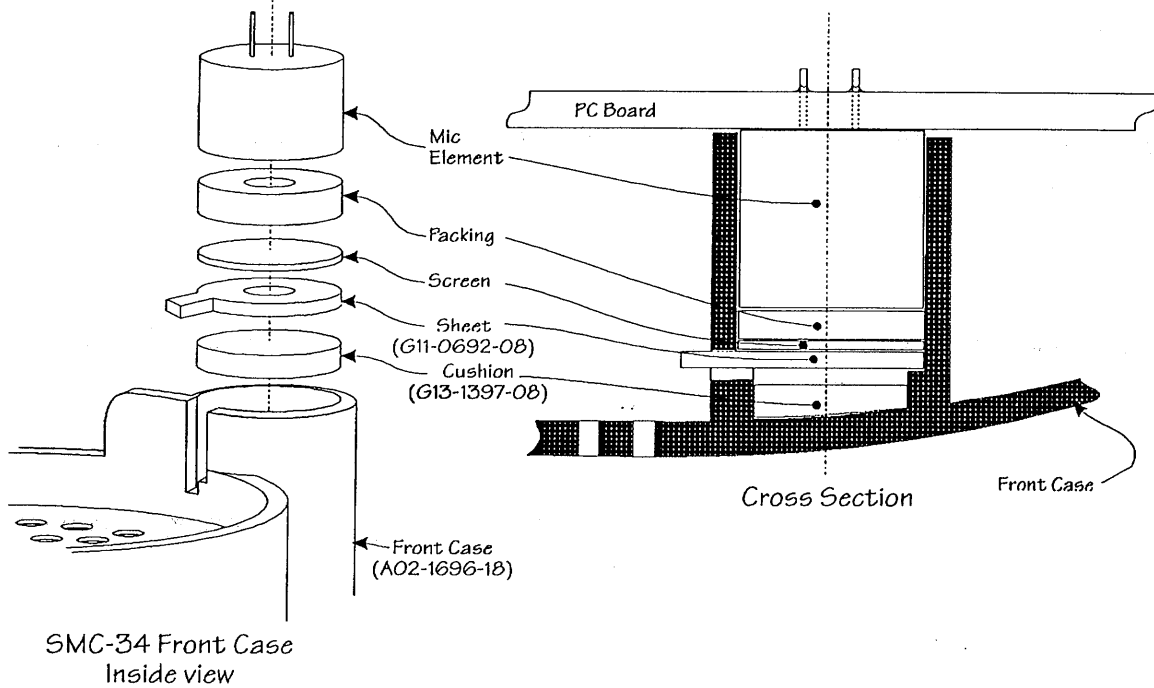
Transmit audio from the SMC-34 sounds distorted or muffled as compared with the audio provided by the transceivers own microphone.

Replace the front case of the microphone, add a cushion inside the microphone well and change the plastic sheet inside the microphone well.

1. Remove the three small black Phillip's head screws from the rear of the speaker microphone.
2. Carefully remove the back cover. The "Lock Switch" lever and the PTT lever can now be removed.
3. Remove the volume control knob by pulling straight away from the case.
4. Remove the two small black Phillip's head screws that secure the PC Board assembly to the front case of the microphone. You can now gently lift the PC Board assembly straight up and away from the front case.
5. Remove the packing, screen, and sheet from the front case of the speaker microphone.
6. Insert the cushion, sheet, screen and backing as shown in the accompanying illustrations.
7. Reverse steps 1 - 4 to reassemble the unit. Note: Carefully remove the rubber gasket from the old front case and position it in the new front case groove before replacing the rear case
