KENWOOD

ASB-1032

Service Bulletin

Subject: TS-450/690S Low Mic Gain w/DSP-100

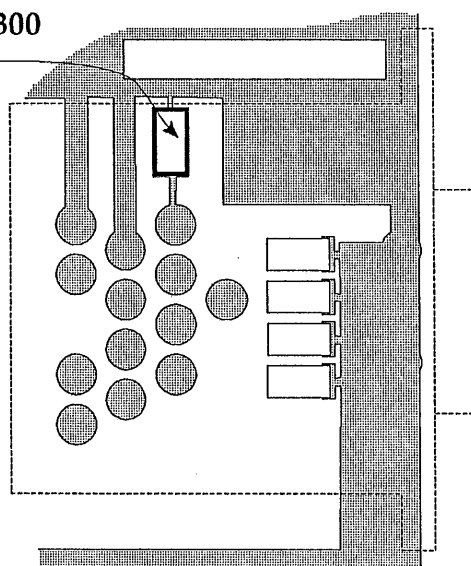
IF Unit (X48-3090-XX)
Foil Side View

Proper microphone gain/ALC readings cannot be obtained unless the user adjusts the TX GAIN potentiometer on the rear of the DSP-100. This irregularity is caused by an instability of the DSP-100 MIC amplifier (IC-5).

Remove capacitor C200 from the IF unit on the transceiver, and replace it with R300, a chip jumper wire.

Replace with R300
(R92-0670-05)
