# KENWOOD

ASB-1035

## Service Bulletin

**Subject:** TS-50S Antenna Lead Wire  
1993

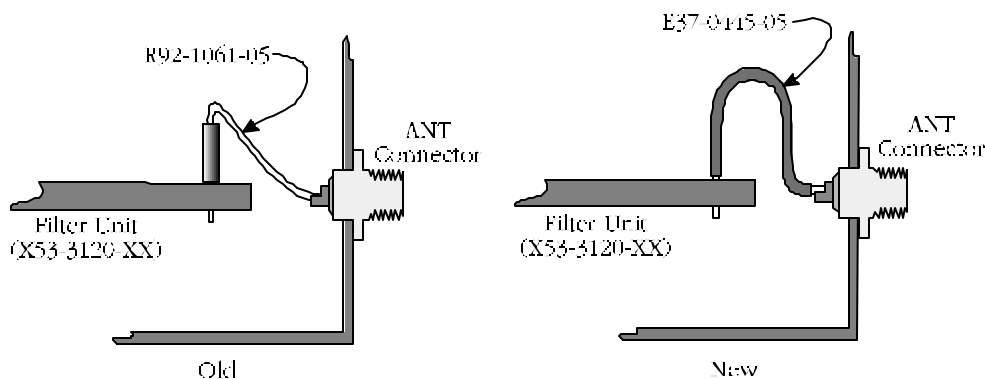
Several users have reported a problem with the antenna lead connection, i.e. the lead that connects the antenna connector to the Filter Unit (X53-3120-XX). Originally this connection was made by a zero ohm resistor. If excessive stress is placed on the antenna connector this lead is easily broken, with a resulting loss of receiver sensitivity and transmitter power. The use of a small flexible jumper wire will increase the flexibility of this connection, thus minimizing the effects of mechanical stress.

Remove the zero ohm resistor and replace it with the small piece of cable. See accompanying diagram.
