ASB-1037

Service Bulletin

Subject: TH-78 IMD Improvements

Date: January 5, 1994

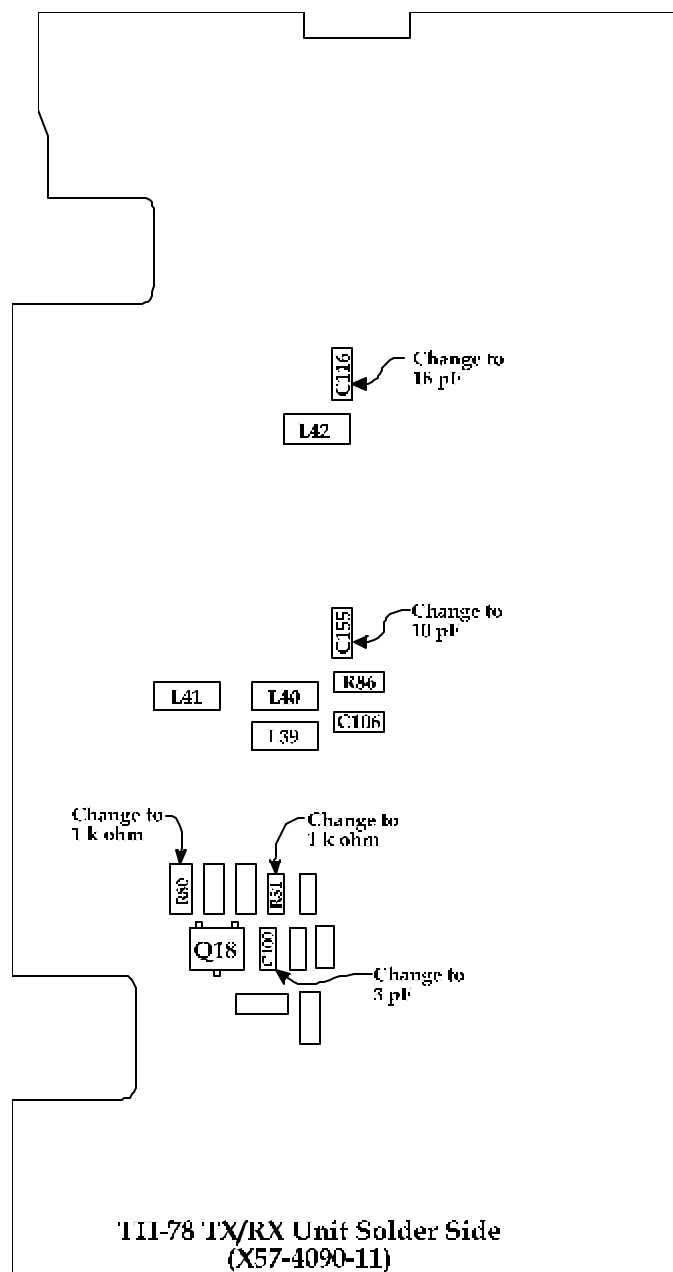
Reports of low sensitivity, improper scanning/no scan, S-meter deflection when the unit is subjected to strong out-of-band signals can all be improved by following this modification.

The following changes will decrease mixer currents and reduces the bandwidth of the Bandpass Filter (BPF).

1. Change R80 from 390 ohm to 1 k ohm.
2. Change R81 from 3.9 k ohm to 3.3 k ohm.
3. Change C100 from 1 pF to 3pF.
4. Change C118 from 33 pF to 18 pF.
5. Change C155 from 1000pF to 10 pF.

(See diagram on page 2 for parts locations.)
