ASB-1048

Service Bulletin

Subject: TH-78AT IMD Improvements
2006

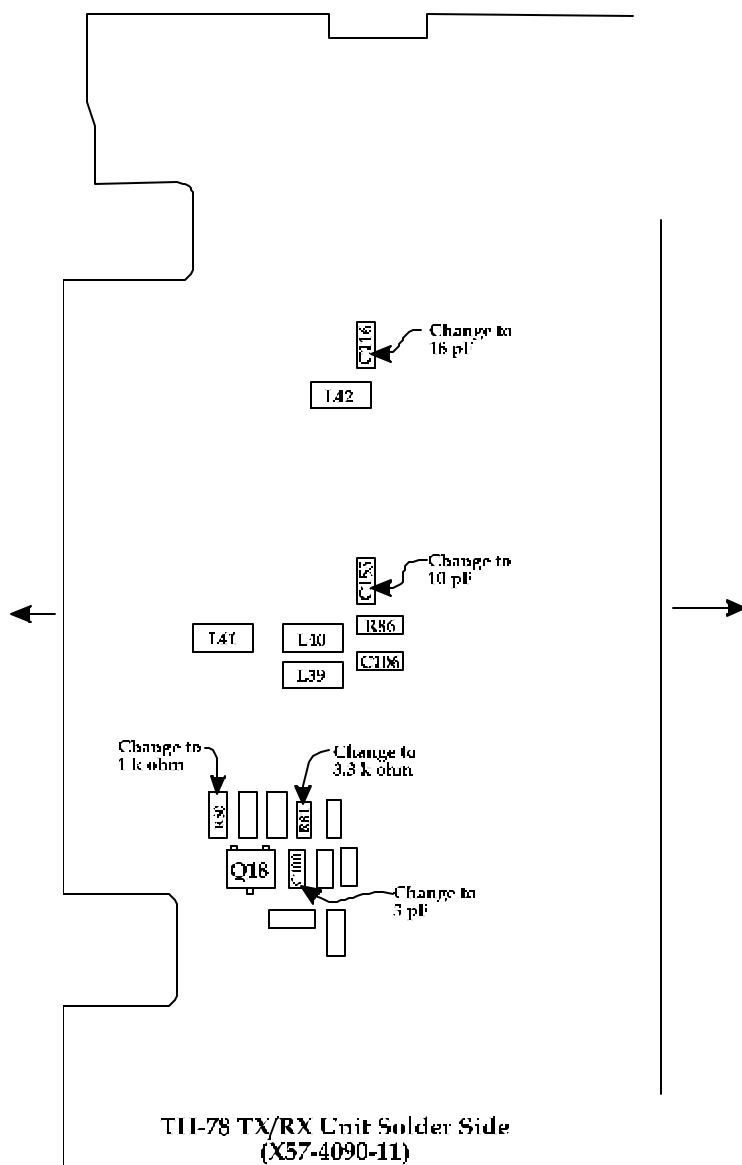
When the transceiver is subjected to a strong electric field, such as might be encountered near an FM Broadcast station, TV Transmitter, or near Land Mobile repeater sites, the sensitivity might be lowered, scanning operation may become difficult or impossible, distortion of the desired signal may be encountered or problems with the S-Meter circuit may become apparent.

Change the components indicated in the chart and accompanying diagram on the TX-RX Unit (X57-4090 B/4) will reduce mixer currents and reduce the bandwidth of the Band Pass Filter (BPF) circuit.

Qty	Description	Old Part No.	New Part No.	Circuit Description
1	1 k Ohm chip resistor	RK73GB1J391J	RK73GB1J102J	R80
1	3.3 k Ohm Chip resistor	RK73GB1J392J	RK73GB1J332J	R81
1	3pF Chip capacitor	CC73GCH1H010C	CC73GCH1H030C	C100
1	18pF Chip capacitor	CC73GCH1H330J	CC73GCH1H180C	C116
1	10pF Chip capacitor	CK73GB1H102K	CC73GCH1H100D	C155
