ASB-1050

Service Bulletin

Subject: TS-950SDX Sub Band Residual Noise

Date: March 28, 1994

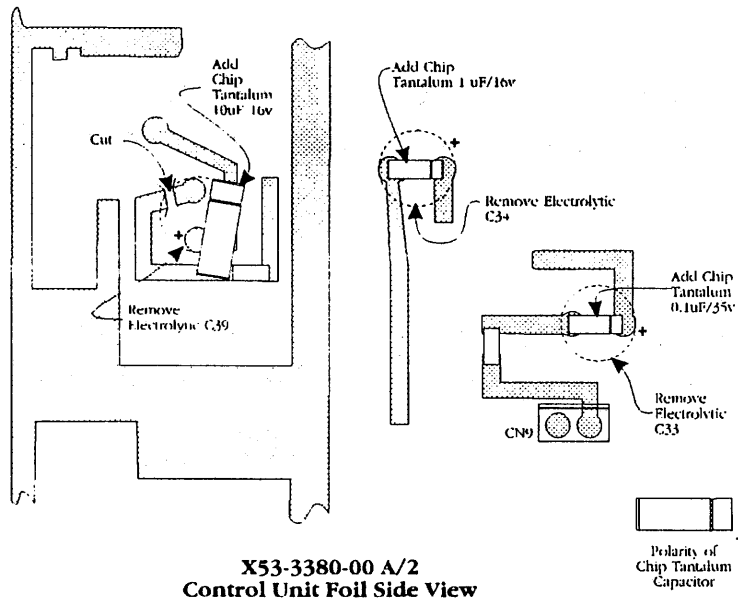
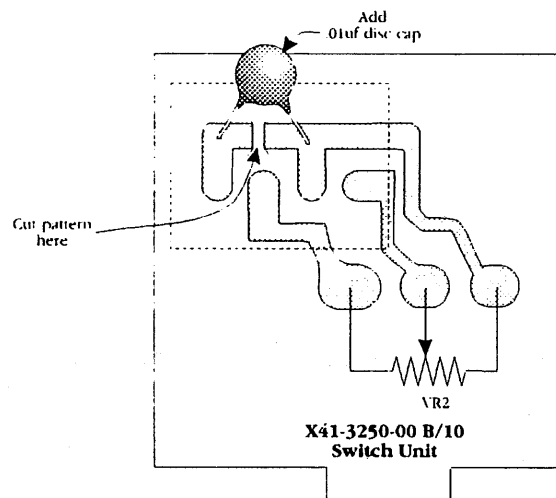
The level of residual noise (AF VOL at Min) on the SUB band is slightly higher than that of the MAIN band. This is especially true at audio frequencies of around 50 Hz, as viewed on a spectrum analyzer. As a result the SUB receiver is more susceptible to motor noise, such as might be generated by fans, refrigerators, etc.

Replacing the Control Unit electrolytic capacitors (C33, C34, and C39) with Tantalum capacitors, and adding the bypass capacitor to the Switch unit reduces or eliminates this symptom.

Qty	Description	Kenwood Part No.	Circuit Description
1	0.1 uF 35v Tantalum cap	C92-0001-05	C33
1	1.0 uF 16v Tantalum cap	C92-0004-05	C34
1	10 uF 16v Tantalum cap	C92-0505-05	C39
1	.01 uF disc capacitor	CK45B1H103Z	NA
